FATALITY ASSESSMENT AND CONTROL EVALUATION

Two Construction Workers Fatally Crushed when Cement Formwork Collapsed Case Report 13NY080

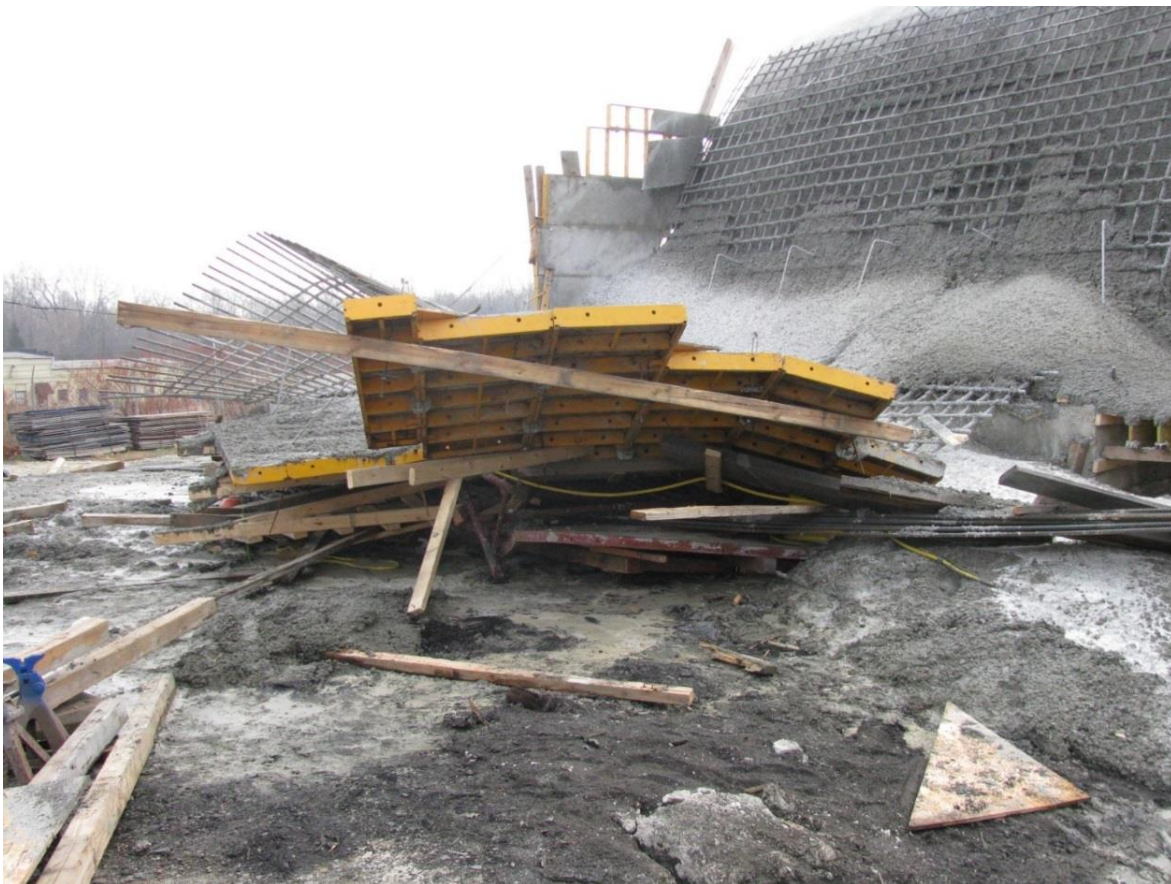
On December 2, 2013, a 53-year-old construction laborer (Victim I) and a 50-year-old concrete pump operator (Victim II) suffered fatal crushing injuries when formwork collapsed during concrete placement at a construction site (Photo 1). The concrete piece being constructed was an aqueduct mockup (Figure 1). On the morning of the incident, the workers were pouring concrete to form the left and right buttress sections and the buttress formwork on the right side collapsed. The right buttress formwork had a retaining wall that was composed of a lower vertical face and an upper inclined face (Figure 2). At the time of the incident, Victim I and Victim II were working from a platform abutting the retaining wall. At around 12:30 pm when the freshly poured concrete was approximately 10 feet high, workers heard loud thudding noises as the retaining wall and the work platform collapsed. A 911 call was placed immediately and EMTs arrived at the site within minutes. Victim I was trapped underneath the formwork and pronounced dead on the scene. Victim II was also trapped underneath the formwork but rescued by other workers who used a forklift to lift the formwork to free him. Victim II died in a hospital nine days later from crushing injuries. Post incident investigations identified several discrepancies between what the formwork design specified and how the formwork was constructed. The formwork deviated from the design specifications in the type, size, and number of anchors to be installed. Pipe braces and hold-down brackets indicated on the drawings were not installed. The formwork did not have adequate capacity to resist the horizontal fluid forces and lacked any mechanism to resist the uplift force on the formwork during concrete placement. The formwork failed due to a combination of mechanisms including formwork uplift followed by wash-out of the wood base platform, vertical drop and collapse of the support wall, and shear/tension failure of the anchoring system.

Photo 1. The site of collapsed form support of buttress section of aqueduct mockup (photo courtesy of OSHA)

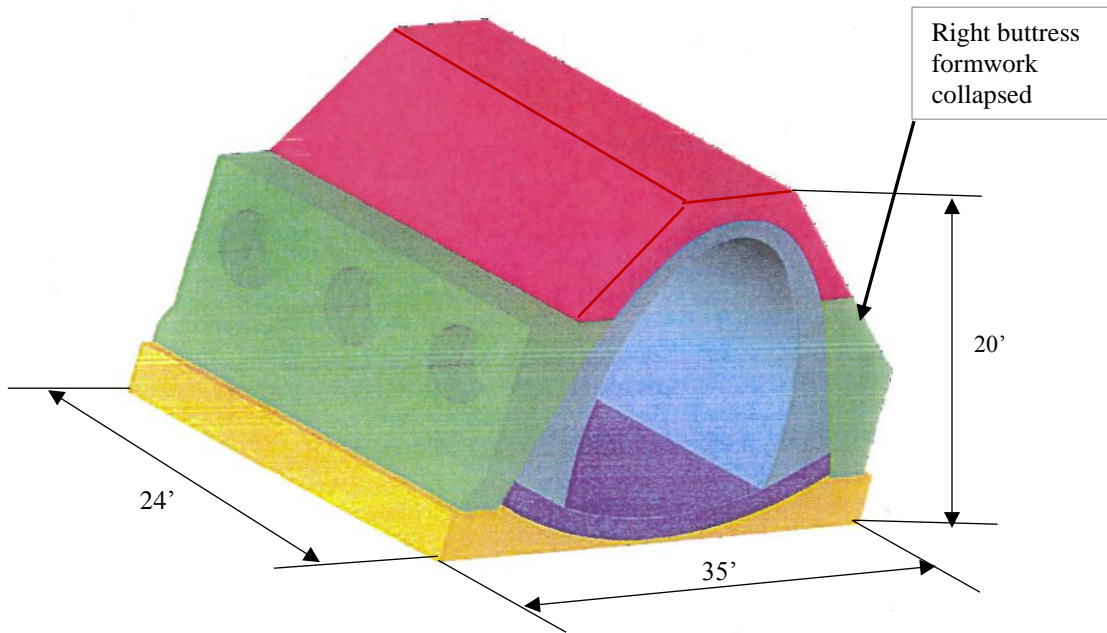
The aqueduct mockup was shaped like an arched tunnel. It was approximately 20 feet tall, 35 feet wide, and 24 feet long (Figure 1). The mockup was to be constructed in five concrete pours:

Figure 1. Aqueduct mockup to be constructed in five pours

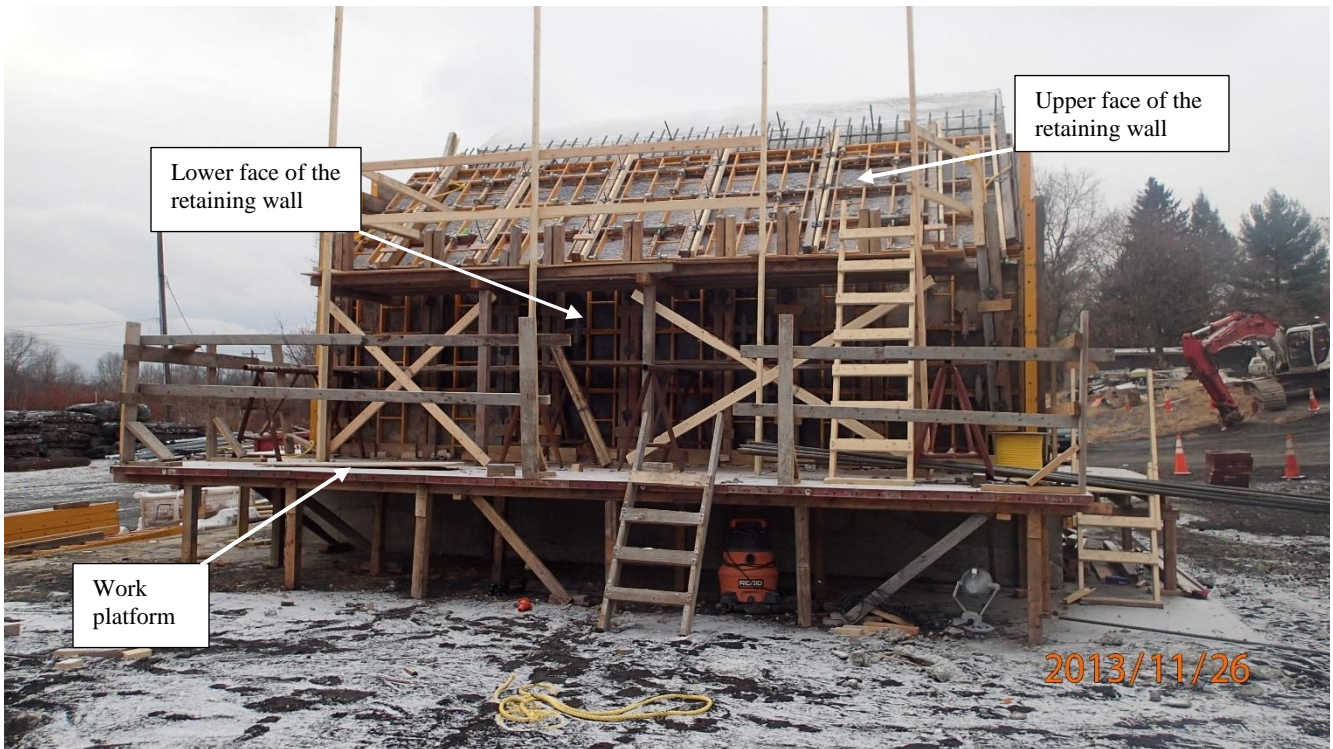
The right buttress formwork was composed of a retaining wall along the length of the mockup and a side panel at each end (Photo 2). The three-sided enclosure was attached and secured to the aqueduct wall. The retaining wall and side panels were built on top of the rock simulation slab. A work platform was constructed abutting the retaining wall.

Photo 2. Completed buttress formwork on the morning of the incident.

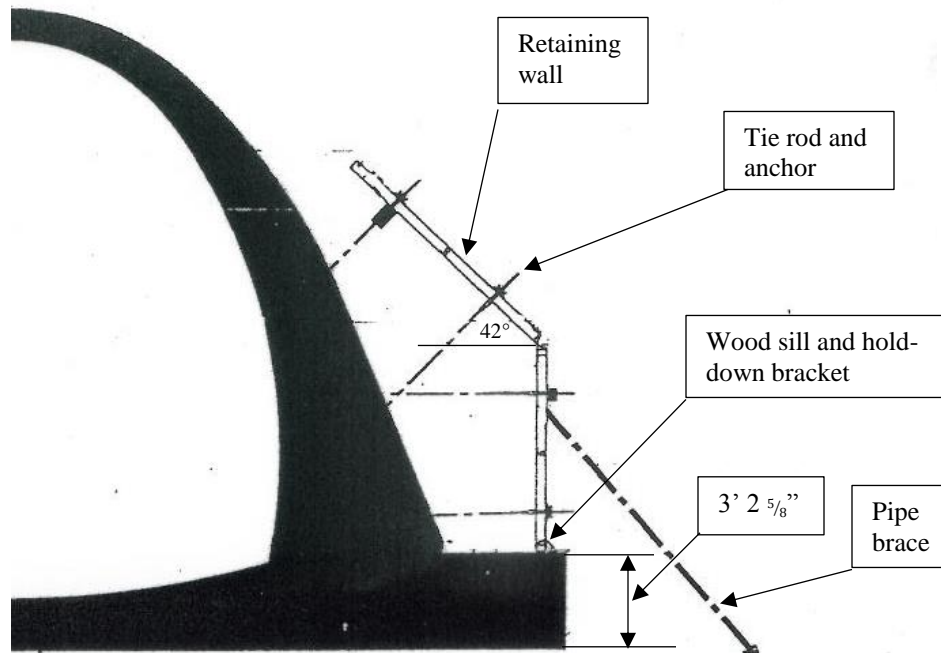
The retaining wall had a lower vertical face and an upper inclined face with a 42-degree slope (Figure 2). The vertical panel was set on the cured rock simulation slab that was approximately 3' 2 5/8" above the ground. Both faces, made of plywood panels with metal framing and timbers, were held up and supported by tie rods that were inserted into the existing concrete structure and secured by anchors, nuts, and bolts. The drawings indicated that wood sill plates and hold-down brackets were to be installed on the base of the retaining wall and that the retaining wall should be braced by pipe braces.

Figure 2. Retaining wall on the cured concrete structure

The drawings indicated five pipe braces (four feet apart) in lengths between 3.6 and 4.8 meters (between 11.8 and 15.75 feet) to be installed at approximate 45° (degree) angles against the vertical formwork face and seated in pipe brace shoes (Figure 2). These pipe braces were to provide additional support to counter the horizontal fluid forces. None of the braces was installed.

The drawings also indicated 3/4" wood sill plate to be secured by hold-down brackets at the base of the vertical wall face (Figure 2). The drawings did not specify the type, size, number, or locations of the hold-down brackets. The hold-down brackets were to be inserted into the rock simulation slab. The sill plate and hold-down brackets were not installed.

The aqueduct drawings in this case indicated five pipe braces to be installed at approximate 45° (degree) angles against the vertical formwork face. These pipe braces were to provide additional support to counter the horizontal fluid forces. None of the braces was installed. The drawings also indicated ¾” wood sill plate to be secured by hold-down brackets at the base of the vertical wall face. The sill plate and hold-down brackets were not installed.

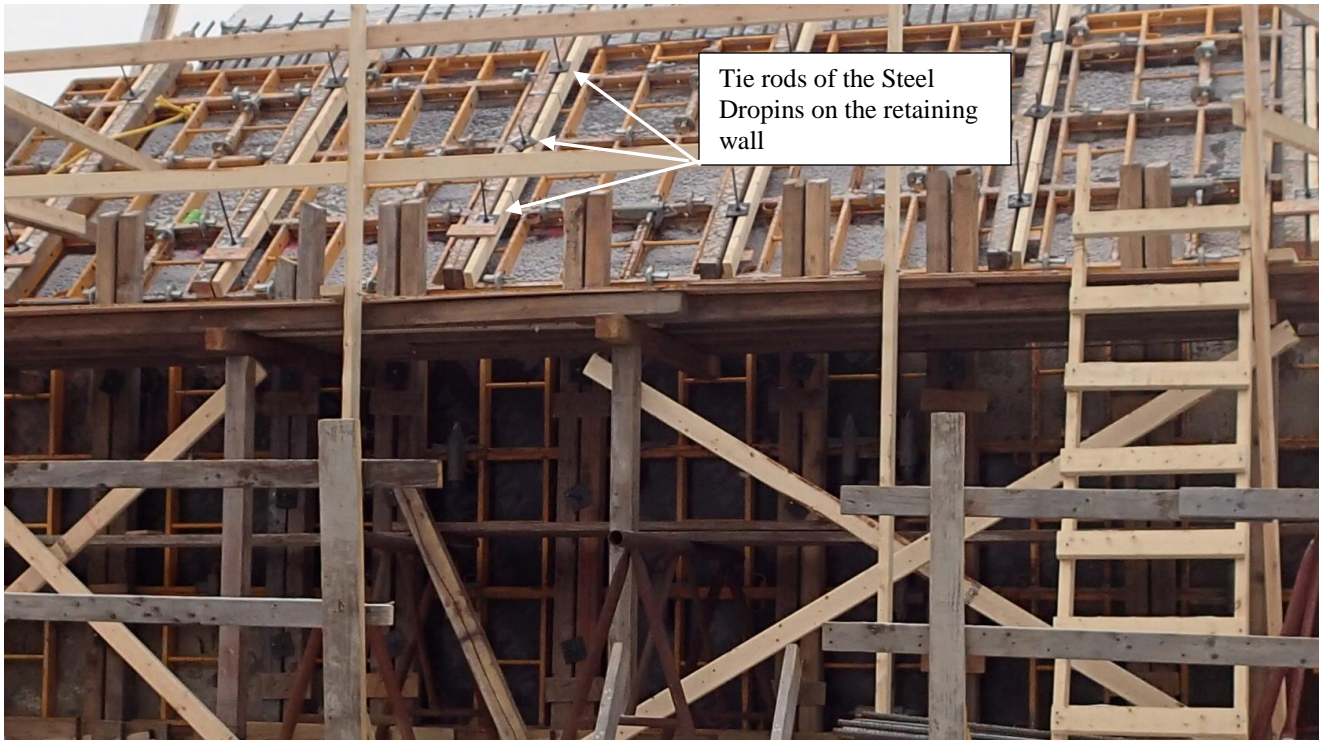
Photo 3. There were approximately 45 anchors on the support wall in six rows: three restraining the lower vertical face and three restraining the upper inclined face (Photo courtesy of NYSDEP).

The total number of the Steel Dropins installed and their exact locations on the retaining wall were not available. The photo that was taken on the morning of the incident showed approximately 45 anchors in six rows; three restraining the vertical face and three restraining the inclined face. Table 1 summarizes how the anchoring systems on the support wall deviated from the design specifications.

The forensic investigators concluded that the primary failure method was anchor failure at the bottom row which caused progressive anchor and formwork failure. Their conclusion was based on two assumptions: 1) there were 24 anchors installed on the formwork; and 2) that the only force on the formwork at the time of structural failure was the horizontal fluid pressure exerted by the fresh concrete. However, the evidence showed otherwise. The anchors in the bottom row did not all fail. In fact, the only anchors on the whole retaining wall that stayed in the concrete were the five anchors in the bottom row. There were approximately 45 anchors on the formwork, far more than 24 (Photo 3). The forensic investigators declined to provide an explanation of their assessment.

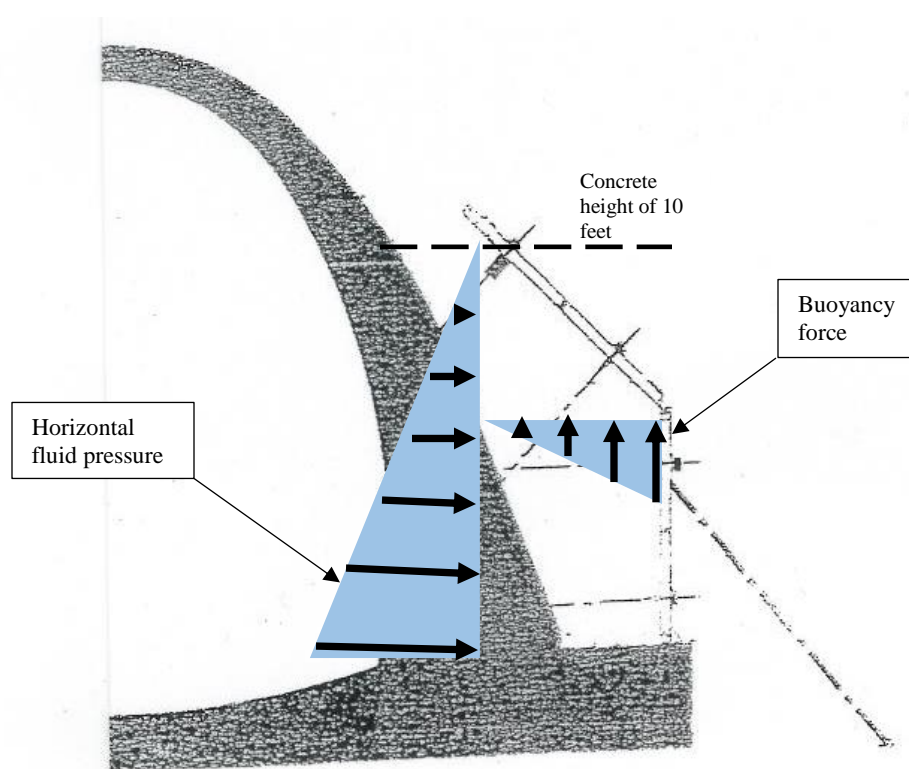
At the time of the incident, there were approximately 10 feet (in height) of fresh concrete that weighed approximately 145 to 150 pounds per cubic foot placed in the formwork. The formwork was subjected to not only the horizontal fluid pressure but also a buoyancy force generated by the upper inclined wall (Figure 3). When fresh concrete pressed against the inclined face, it generated an uplift force that would move the formwork upward. The only mechanism on the retaining wall that might have had some capacity to resist uplift was the hold-down brackets. The design did not provide any specifications on the type, size, and installation requirement of the hold-down brackets and the hold-down brackets were never installed.

Figure 3. Illustration of direction and distribution of forces on the formwork at the time of collapse

The formwork failed due to a combination of mechanisms including formwork uplift followed by wash-out of the wood base platform, vertical drop and collapse of the retaining wall, and tension failure of the anchoring system. The failure likely started with a release of fresh concrete at the base of the formwork, as evidenced by the work platform being thrust a distance away from the concrete wall significantly greater than its original height from grade. The release of concrete at the base was likely caused by the uplift of the vertical face due to the buoyancy force.

The formwork in this case did not have adequate capacity and mechanisms by design to resist the forces and prevent the formwork from moving upward. The buoyancy force was generated by the inclined wall face. The only mechanism that might have resisted the buoyancy force was the wood sill plate and hold-down bracket. However, the drawings did not specify the type, size, and installation requirement. Employers should ensure that the drawings have clear specifications on the mechanisms that are critical for preventing formwork failure.

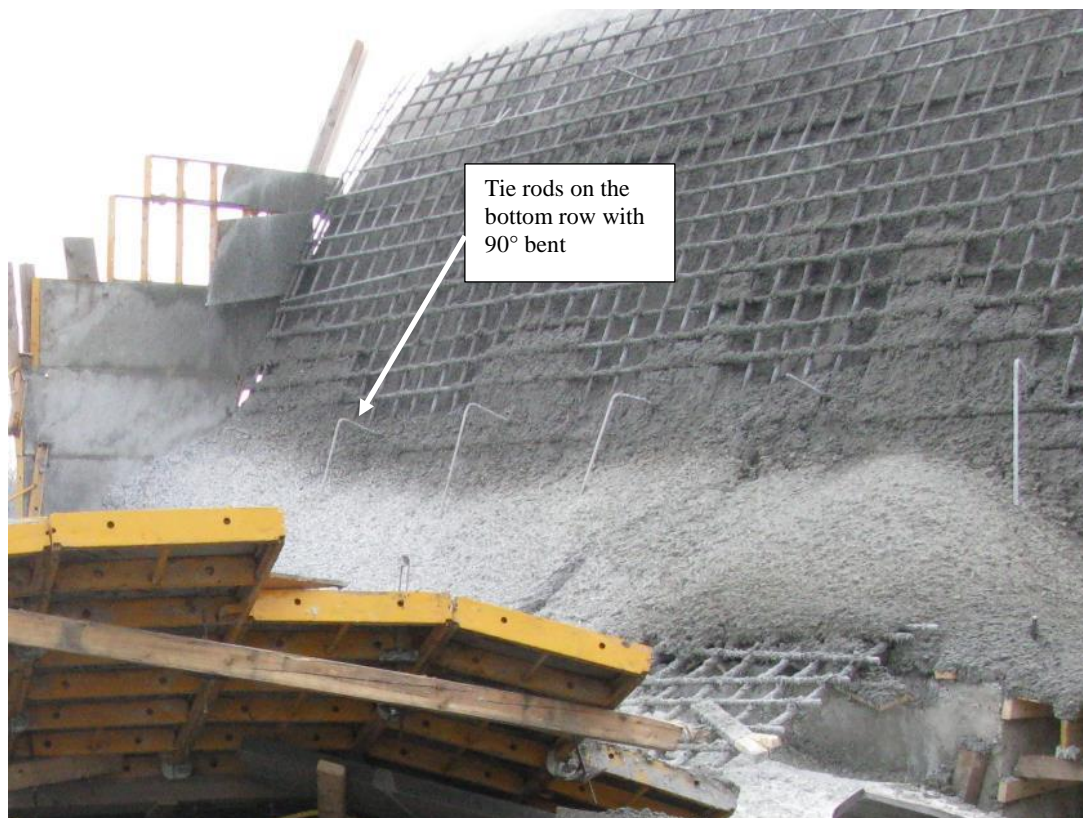
The retaining wall was then pushed away from the mockup and fell vertically off the slab. There were five anchors near the bottom that remained embedded in the concrete section. These rods remained perpendicular to the concrete section for a short distance and then bent at a sharp, nearly 90° angle downward (photo 4). This suggests a vertical drop in the formwork wall prior to major lateral movement. Tension failure of the anchors was the third and last stage of failure, allowing lateral rotation of the formwork about its base and away from the mockup.

Photo 4. Tie rods that remained on the concrete bent at a nearly 90° angle suggesting a vertical drop in the retaining wall during collapse (photo courtesy of OSHA).
