FATALITY ASSESSMENT AND CONTROL EVALUATION

Farm Worker Dies during Manure Truck Overturn Case Report: 02NY069

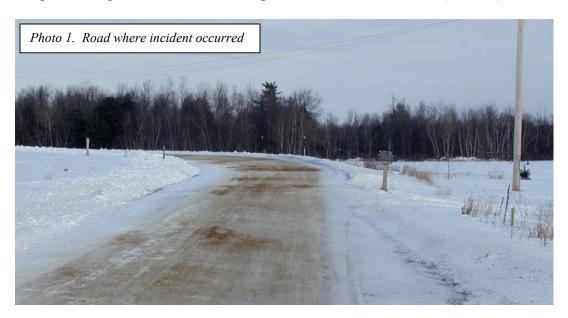
On this day, at approximately 3:35 PM, the employee was taking his seventh load of manure out from the farm to spread in the field location. He had traveled approximately one-quarter mile down the dirt road by the farm and was at a 90-degree bend in the road requiring a left-hand turn (Photo 1). As the employee approached the turn, the farm owner was travelling toward the same turn in an on-coming pick-up truck. The tractor-trailer driver swung wide to the right-hand side as he made the left-hand turn. The farm owner stated that as he passed the tractor-trailer he looked back in his rearview mirror and noted that the side tractor-trailer wheels began to come up and the tractor-trailer subsequently overturned. The tractor-trailer had overturned off the right-hand side of the road, making a 270-degree rollover and coming to rest on the driver's side (Photo 2).

It is believed that as the employee drove the tractor-trailer down the narrow two-lane dirt road, his normal custom was to cut across the lane and stay on the left-hand side of the turn as he proceeded through this 90-degree turn. At the time of the incident, since another vehicle was coming toward him, he needed to stay on the right side. He was travelling an estimated 30 MPH at the time of the incident and as he entered the turn, the tractor went around the turn and the rear end of the trailer tank swung out to the right and off of the roadway. As it left the normal track of the roadway it caused the tank to begin to roll over, affecting the tractor and rolling the entire tractor-trailer unit over, coming to rest on the driver's side, after completing 270 degrees of roll.

On the embankment, the road sloped down at approximately 30-degrees, with loose gravel in this portion. It is believed that as the right side trailer tank wheels began going down over this gravel area that it caused the liquid manure to shift, helping to create the rollover due to added momentum provided by the load shifting within the tank. This particular 9,000-gallon tank was divided into five separate sections with internal baffles separating the tank front to back. The internal baffles had an approximate 12-inch diameter hole cut in the bottom of each one to allow the liquid to travel from the front section back through the midsections to the rear section where it would be discharged through the spreading system. The baffles provided protection against liquid sloshing forward and backward and divided the load into five equal segments within the tank. They did not, however, prevent side-to-side movement of the liquid within those cells.

Discussion: In this scenario, the tractor-trailer was traveling at an excessive rate of speed for the given road conditions. Since the road was a small two-lane dirt road with an acute 90 degree left hand turn, the tractor-trailer was traveling at too great a speed to safely negotiate the left-hand turn. The only route that would allow the vehicle to successfully make the left-hand turn at that speed was by crossing over into the on-coming lane during the turn. Since a vehicle was approaching in the on-coming lane the tractor-trailer had to remain in its own lane during the turn.

Recommendation #1: Tractor-trailers should be driven at operating speeds appropriate for roadway conditions.

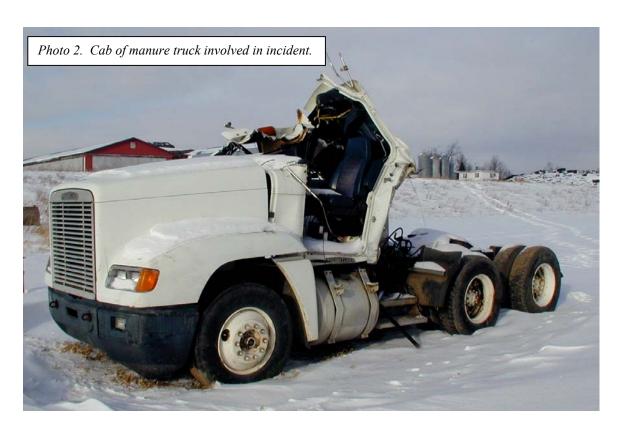
Discussion: In this scenario the 9,000 gallon trailer had been partially filled with between 6,000-7,000 gallons of liquid manure. This represents between 40,000-50,000 pounds of material. This tank contained baffles that divided the tank from front to back. These prevented forward to back movement of the manure but did not prevent sideways movement of the manure. Since the tank was only partially filled, and due to the type of baffles, the liquid was allowed to shift to the side during the turn. This caused the center of gravity to shift to the right adding to the right-hand side momentum of the vehicle during the turn.

Recommendation #2: Liquid trailer tanks should be filled to capacity to ensure safe transport given the nature of the internal material and the road conditions.
