# STATE OF NEW YORK DEPARTMENT OF HEALTH

## FATALITY ASSESSMENT AND CONTROL EVALUATION

### Dairy Farm Owner Dies during Manure Pump PTO Entanglement Case Report: 04NY010

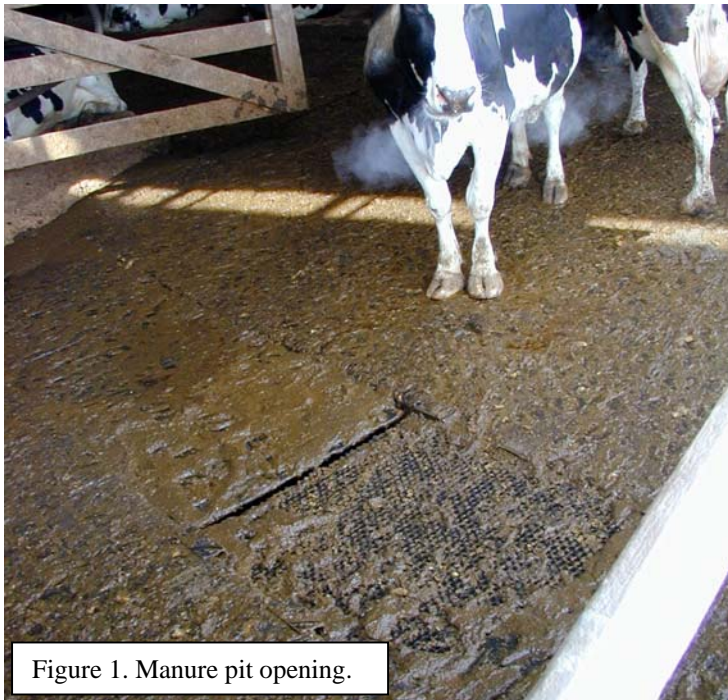
On February 20<sup>th</sup>, 2004, the farm owner was transferring liquid manure from an underground manure storage pit (Figure 1) in the end of the dairy barn to a manure lagoon that was located outside of the barn. On this particular farm, the freestall barn that housed the dairy cows was designed with two underground manure storage pits. The manure was scraped into the pits and held there until the level necessitated transfer of the manure to a larger outside storage lagoon. The freestall barn contained two separate manure storage pits that were 34 feet long by 10 feet deep and 10 feet wide. The manure from these pits needed to be transferred approximately once a month to

Figure 1. Manure pit opening.

**Discussion:** In this scenario, manure was scraped from the barn, collected in the manure storage pits and then transferred monthly to the manure lagoon. Many manure handling system designs eliminate the intermediary collection stage and manure is immediately directed to the manure storage lagoon. A design that eliminates manure collection in storage pits would eliminate the need for subsequent transfer of manure with pumps.

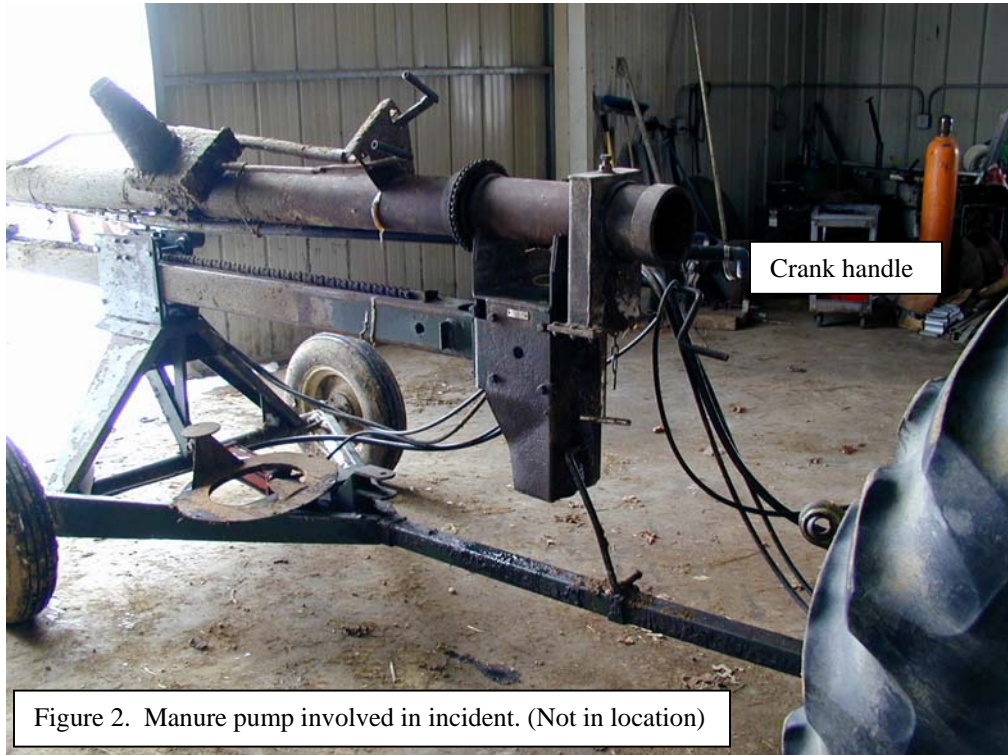
the manure storage lagoon located outside. To perform the transfer, the farmer utilized a liquid manure agitation and transfer pump. The Husky brand manure pump (Figures 2 and 3) was connected via a 540rpm PTO to a John Deere 4230 tractor with approximately 120 horsepower. The manure pump was a 12-year-old model that had worked well prior to the incident.

Figure 2. Manure pump involved in incident. (Not in location)

The sheriff noted during extrication of the victim that the victim's clothing was caught on the PTO shaft and had pulled the victim into the shaft. The PTO shaft was not guarded with a shaft shield and there were also two shear bolts protruding from the shaft, one at each end. These quarter-inch shear bolts were broken at the time of the extrication of the victim, but it is believed that these bolts caught on the clothing of the victim initially, entangling him in the shaft. These shear bolts are present so that if the manure pump becomes clogged or encounters an obstruction, they shear prior to serious damage to the pump. In this case, the PTO shaft had these shear bolts protruding since there was no shaft shield in place to guard against contact with them.

**Recommendation #1:** *PTO-powered equipment should not be operated unless the PTO shield is in place and in good condition.*

**Recommendation #2:** *Power to equipment should be turned off prior to making mechanical adjustments.*
