# STATE OF NEW YORK DEPARTMENT OF HEALTH

## FATALITY ASSESSMENT AND CONTROL EVALUATION

### Worker Fatally Injured by Steel Blade While Cleaning a Dough Machine

Case Report: 02NY096

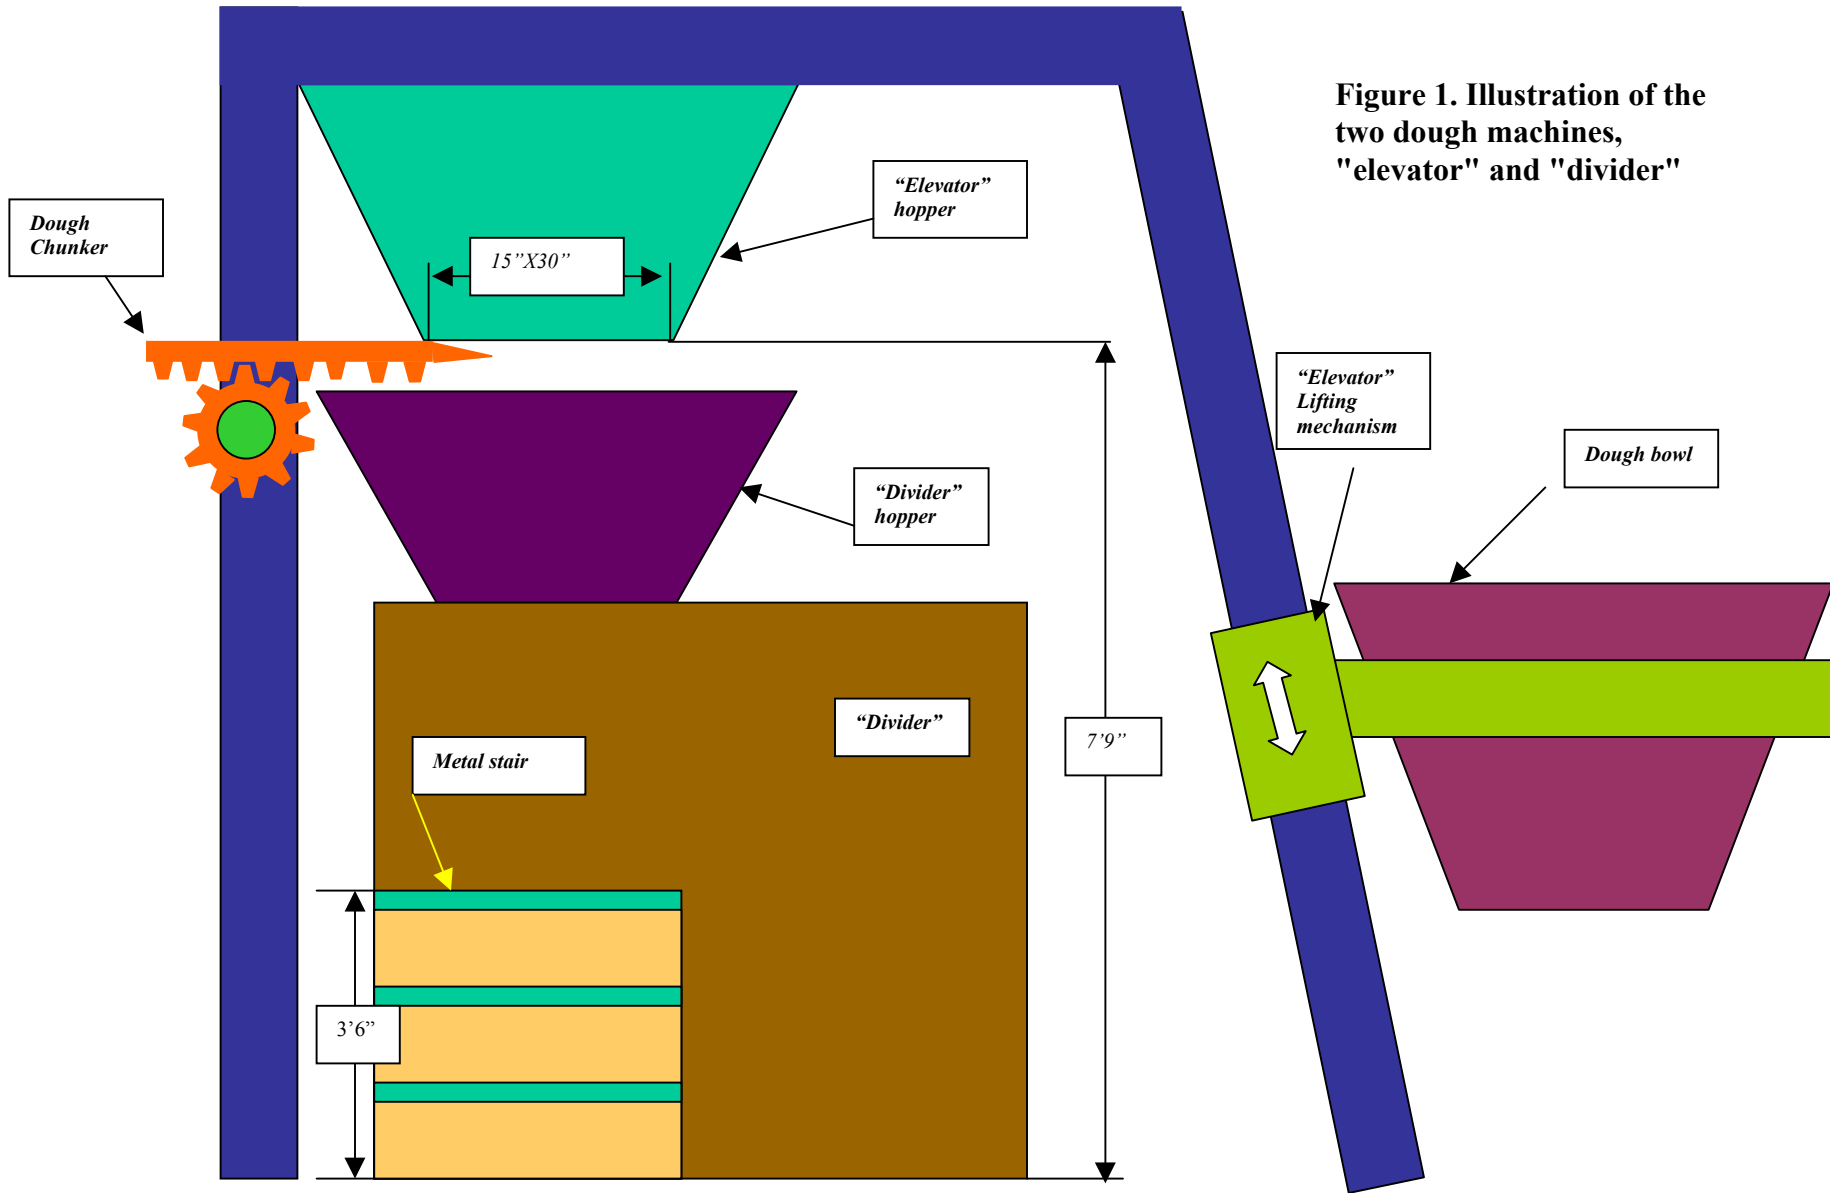
**Figure 1. Illustration of the two dough machines, "elevator" and "divider"**

The first of the four dough machines was called an "elevator". The "elevator" was electrically powered and had three major components: a lifting mechanism, a hopper, and a sharp steel blade called the "dough chunker" (see Figure 1). The "elevator" raised the dough in a mixing bowl and dumped it into the hopper. The "dough chunker", located at the bottom of the hopper opening, was powered by an electrical motor (3/4 HP). When activated, the blade moved back and forth at a speed of approximately six inches per second, cutting the dough falling from the hopper. The dough then went into a "divider" hopper underneath the "dough chunker". The "divider" was the next dough machine after the "elevator" in the dough making line.

On the day of the incident, production stopped around 3:30 PM and the workers started daily sanitation of the dough equipment. The victim and the co-worker were assigned to clean the “elevator” and the “divider”. Before starting the sanitation, the victim turned off and locked the power switches of the two machines. However, the first two “dough chunker” buttons were left on “On” and “Auto”. The two workers then started routine sanitation of the machines. They first pushed the “divider” hopper back so that they could clean the “elevator” hopper from underneath. They removed all the plastic liners from the hoppers and brought them to a sink for rinsing and cleaning. At approximately 4:15 PM, the co-worker was about to clean the dough bowl. In order to clean the outside of the bowl, he had to have the bowl raised by the “elevator”. He went to the victim and asked him for the key to unlock the main power switch of the “elevator”. At this point the victim was in the middle of cleaning the inside of the “elevator” hopper. He was standing on a metal stair, bending over and extending his head through the bottom opening of the hopper and wiping the inside of the hopper with a rag. When asked by his co-worker, the victim handed out his key. The co-worker took the key, walked to the control panel, unlocked the main power switch, turned it on, and started raising the bowl. A few seconds later, the co-worker heard noises made by the victim and immediately pushed the emergency stop button to stop the machine. The co-worker rushed to the victim and found that the victim appeared to be partially decapitated from behind by the energized chunker blade as it went through its automatic cutting cycle. The co-worker called a shift supervisor for help. The shift supervisor summoned the paramedics who arrived within five

**Discussion:** The standard "elevator" sanitation procedure should be modified to avoid placing the workers' body into the point of operation. For example, cleaning may be performed from above the top hopper opening using a brush with a handle. Workers should receive training on the modified cleaning procedure.

**Discussion:** The employer should explore and research options for installing interlocks on the dough equipment to eliminate human errors during the lockout process. For example, the “divider” hopper could be interlocked with the “elevator”. Therefore, when the “divider” hopper is pushed back during cleaning or maintenance, there would be no power to the “elevator”. Only when the “divider” hopper is back to its normal production position, which means that the sanitation or maintenance is complete, can the power to the “elevator” be restored.

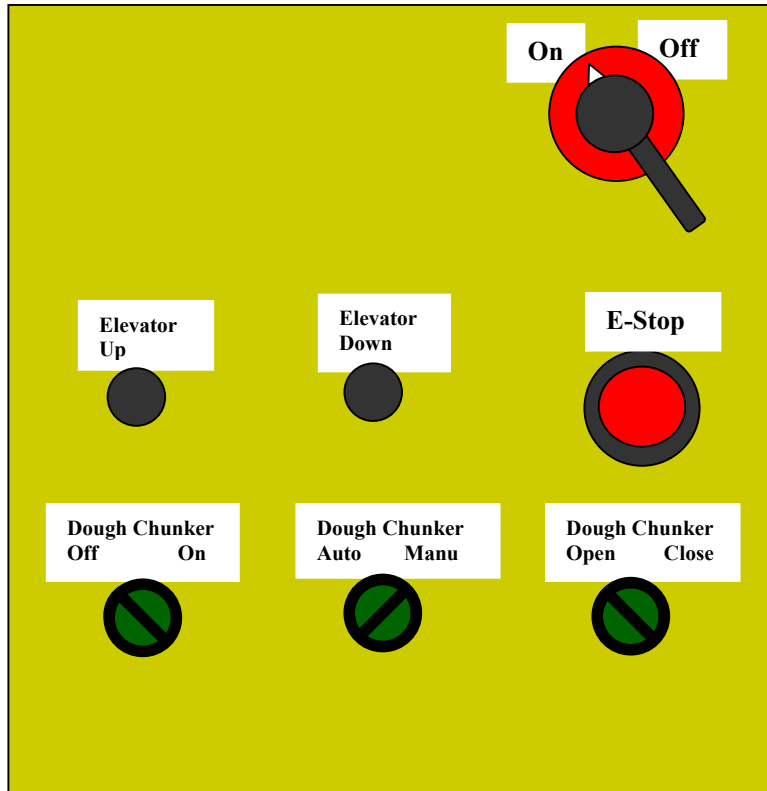
Figure 2. Illustration of the “elevator” control panel

The "elevator" control panel is shown in Figure 2. There were a total of seven buttons and switches. The main power switch was a spring-loaded mechanical lever switch that had "On" and "Off" positions. The lifting mechanism of the "elevator" was controlled by the main power switch and the two "elevator" control buttons. The "dough chunker" was controlled by the main power switch, and the three "dough chunker" buttons. If the main power switch was off, the "elevator" had no power. If the main power switch was on, depending on the different "dough chunker" control settings, the "dough chunker" could either cut automatically or have no movement at all (see Table 1).

During normal production, the “dough chunker” was mostly set to the “On” and “Auto” modes, and was activated by a sensor located inside the “divider” hopper underneath the blade. The sensor would signal the steel blade to cut based on the amount of dough in the hopper. If the “divider” was turned off and the sensor was not activated, the blade would go through its automatic cutting cycle every 20 to 30 seconds.

The company lockout/tagout program required a “three-point lockout” for the “elevator” and the “divider”: the main power switches of the “elevator” and the “divider” and a lubricating pump for the “elevator” and the “divider” had to be turned off and locked. One important step before turning off the main power switches was to turn off the “dough chunker” and set it to manual mode. According to the plant’s management, all workers received hands-on training on this specific shut down procedure. However, the company did not have this procedure in writing in the “elevator” lockout/tagout manual.

**Discussion:** The company lockout/tagout program at the time of the incident did not have the specific "elevator" shut down procedure in writing. The employer should evaluate all dough making machines and develop specific lockout/tagout written procedures for each machine. The written procedures may include orderly shutting down, testing to ensure that the equipment is isolated from its energy source, releasing potential stored energy, and locking and tagging out the energy isolation device. Certain machines, such as the "elevator" have multiple control buttons and switches that are to be properly set during an orderly shut down. A chart showing the lockout positions of all the control buttons and switches may be placed next to each control panel.
