# STATE OF NEW YORK DEPARTMENT OF HEALTH

## FATALITY ASSESSMENT AND CONTROL EVALUATION

### Maintenance Mechanic Killed when Improperly Installed Overhead Garage Door Toppled Scissors Lift Case Report: 04NY135

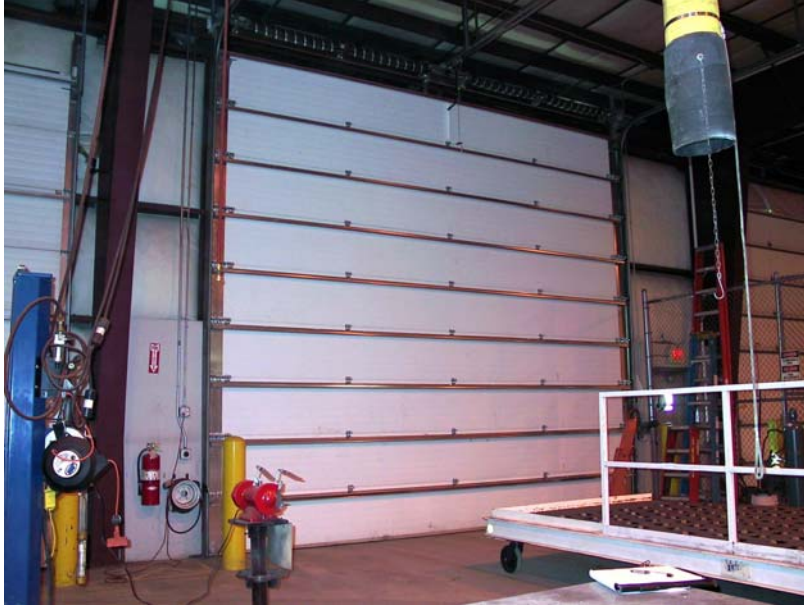
Following installation, the new door did not operate properly and the top door panel was bent in the middle. The victim and a co-worker returned to the cargo building on December 9 to make adjustments. They examined the door and then called the overhead door sales company to discuss the problem. The owner of the garage door company stated that he had several phone conversations with both the victim and his employer. In order to assist in determining a solution, the owner of the garage door company needed to know the door lift type and the size of the lift drums. The victim and his employer told the door company owner that the new door was a high-lift door with eight-inch lift drums; although, in fact, the door was a standard lift door with six-inch lift drums. Based on the incorrect information provided by the maintenance firm, the owner of the overhead door company recommended installing two additional torsion springs to balance the weight of the door. It was also recommended that a piece of angle iron be installed across the bent section of the top panel to straighten the panel and improve the door operation.

*Photo 1. The overhead door that was involved in the fatal incident: a standard lift steel insulated door with six-inch lift drums. The door in the photo was adjusted and repaired by a garage door technician after the incident.*

The owner of the garage door company went to the cargo terminal building several days after the incident to repair the door for the shipping company. According to the garage door company owner, the facility maintenance firm made multiple mistakes when installing the overhead door: the hinges and the tracks were both installed incorrectly, and the door panels were placed upside down and inside out. If the door had been installed properly, the rollers would have been able to move easily inside the tracks. The incorrectly installed hinges and tracks inhibited the rollers' movement and caused the door to jam. The overhead door was a standard lift door with six-inch drums. The two torsion springs later recommended were for a high-lift door with eight-inch lift drums; this was the door model mistakenly reported to the garage door company owner. It could be reasonably speculated that the force applied by the torsion springs was incorrect for this door. These mistakes may have caused the unbalanced door to spring up after the door was manually released.

**Discussion:** The installation/service maintenance manual for the overhead door was not available for the workers while they replaced the door parts and serviced the door. When working on overhead doors, employers should ensure that an installation/service manual is available for reference and that workers follow the manufacturer's recommendations.

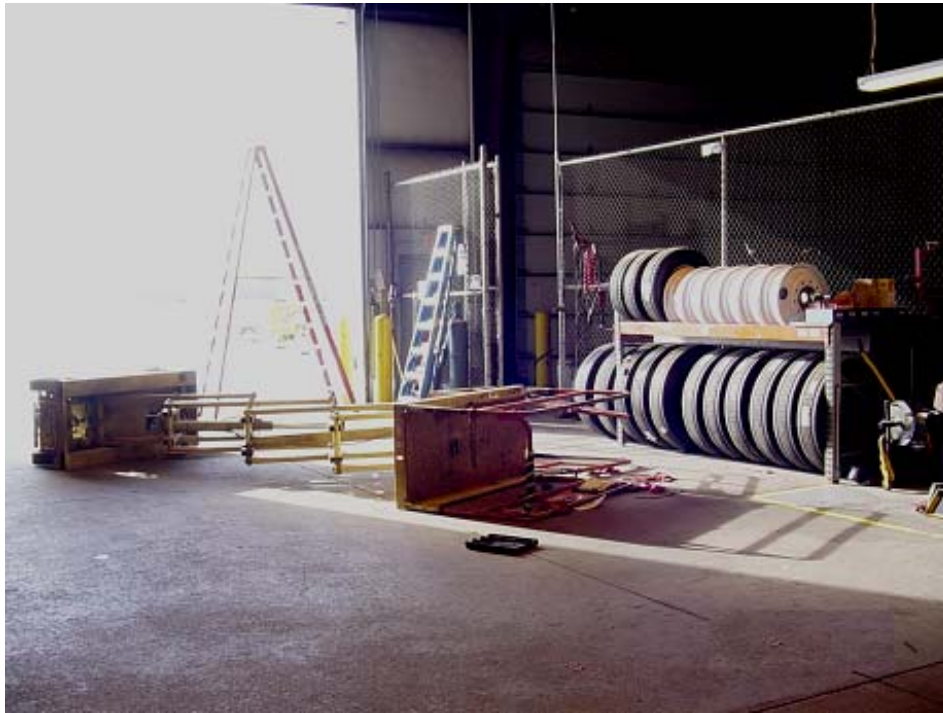
At approximately 7:00 p.m., the victim was working on the platform of a scissors lift that was extended approximately 15 feet above the ground and parked parallel to the door. No additional fall protection was used. Fall protection is not required by OSHA when operating a scissors lift with a standard guardrail system. The victim first tried to manually disconnect the door arm assembly from the track with the emergency release handle by pulling the handle and cord assembly, but it would not release. He then asked for a screwdriver. At this time, the co-worker and a shipping company mechanic were both in the area on the ground. The shipping company mechanic provided a screwdriver to the victim. The victim used the screwdriver to pry the emergency disconnect away from the chain drive assembly. According to the co-worker, both he and the victim anticipated that the door would go down upon being manually released due to its weight. However, the door abruptly sprang upwards to the fully open position, striking the guardrail of the scissors lift, and causing the lift to topple to the concrete floor. The co-worker and the shipping company mechanic ran to the victim who had fallen out of the lift and was lying on the concrete unresponsive. The mechanic called 911. The EMS squad and police arrived within minutes. The victim was quickly transported to a hospital where he was pronounced dead.

*Photo 2. Post incident scene: the scissors lift was struck by the garage door after the door was released by the victim, toppling the lift. (Courtesy of OSHA)*

According to the post-incident examination, the scissors lift had been operated within the scope of the technique specifications and performance capacity at the time of the incident. There were no known mechanical defects or malfunctioning parts on the scissors lift that may have contributed to the incident.

**Discussion:** A jammed door may have tremendous potential energy that may be released suddenly when the jam is cleared. Workers should stay clear of overhead door paths. The door path should also be clear of any lift or other equipment that may cause injury if struck by the moving door.
