A NY FACE Training Guide for Health & Safety Professionals

**MODULE 1: PREVENTING DEATHS AND INJURIES TO
PUBLIC WORKERS WHILE WORKING AROUND
MOBILE EQUIPMENT**

Truck Driver Run Over by Trash Compactor at Municipal Landfill Case Report: 02NY007

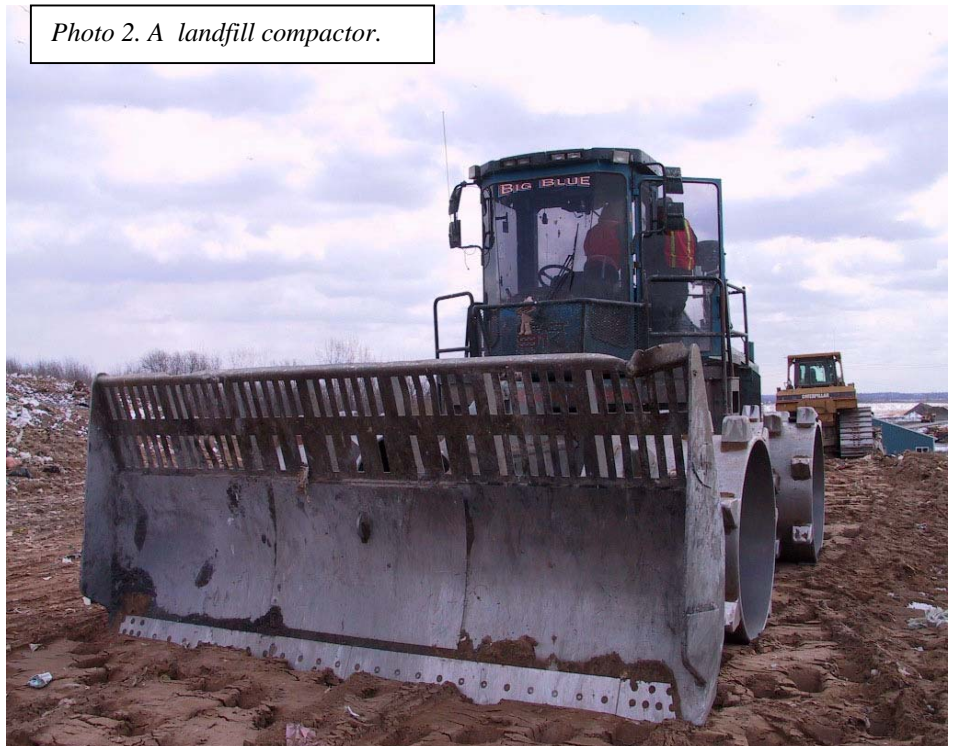
Photo 2. A landfill compactor.

Each landfill compactor used at the time of the incident was about 30 feet long and 15 feet wide and weighed about 100,000 lbs. (Photo 2). It was an articulated vehicle with a front plow to push and spread the waste and sand, and with two sets of double metal wheels to crush and compact the waste. Each metal wheel was six feet in diameter and had 28 evenly staggered triangular metal cleats that were eight inches in height (Photo 3). The compactor moved at a speed of five to six miles per hour. The vehicle had an audible backup alarm, a rearview mirror in the cab and four side mirrors, two on each side.

Because of the length and height of the vehicle, the operator's blind spot extended from the rear of the vehicle up to 35 feet behind; the operator could not see a person unless he or she stood further than 35 feet away from the rear of the compactor.

Recommendation #3: Landfill employers should consider using additional safety devices for landfill equipment, to warn drivers when someone is in their blind spot.

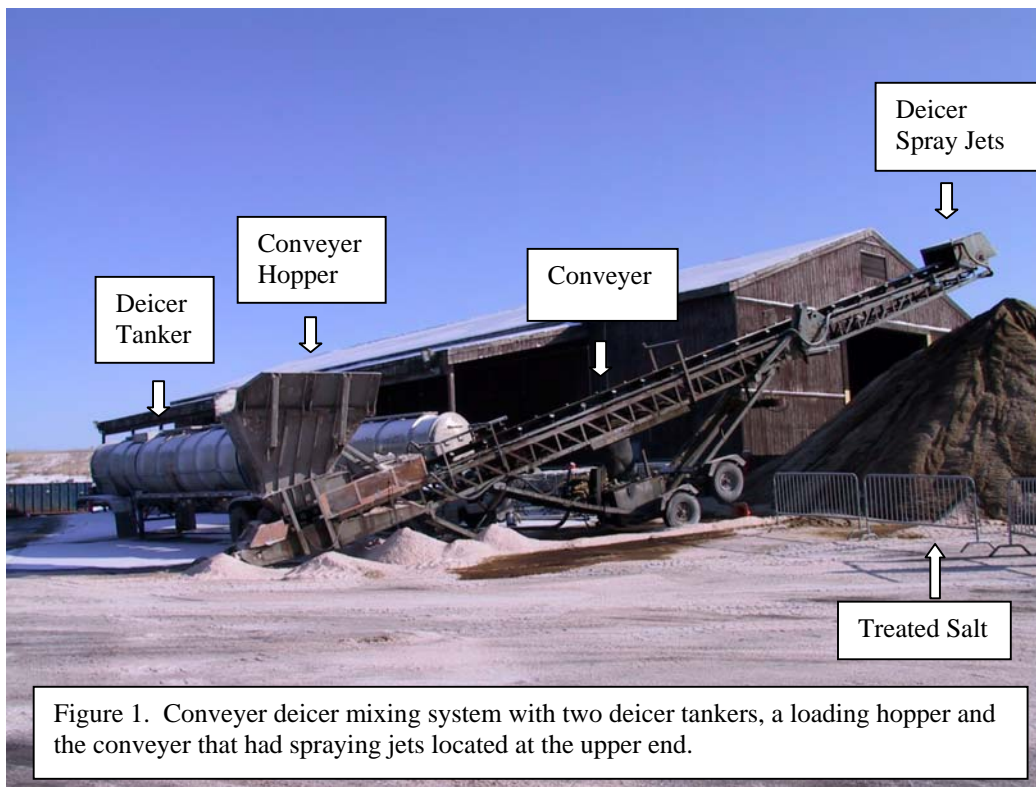
The stacking conveyer (Figure 1) was capable of processing approximately 300 tons of salt per hour. The mixing system had a set of six jets located at the top of the conveyer. The deicer was injected through the jets and sprayed onto the salt right before the salt fell off the belt. The conveyer mixer was equipped with a filtration system that was designed to prevent the jets from clogging up. The controls of the mixing system were located at the north side of the conveyer (Appendix A). When operating the conveyer, the victim stood between the deicer tankers and the conveyer where there was no loader traffic. However, according to the EOs, the spray jets kept clogging that day and the victim had to walk around the salt piles and enter the loader working area to perform maintenance.

Recommendation #8: *Distributing companies should modify equipment to reduce maintenance during operation so operators can avoid entering loader working areas.*

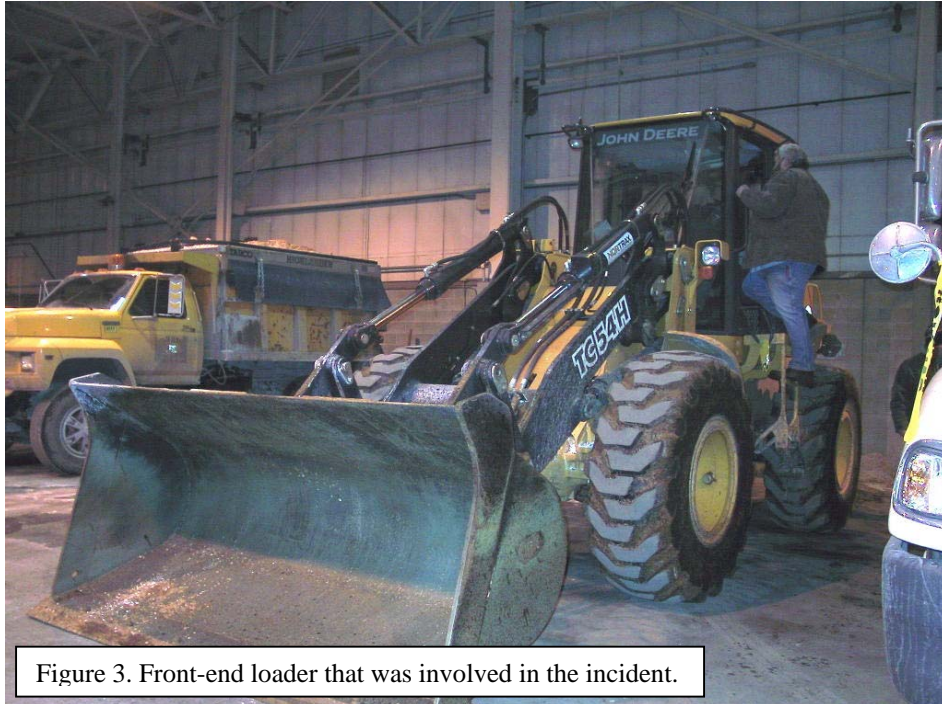
Figure 3. Front-end loader that was involved in the incident.

Operator A used a 2003 John Deere TC 54H wheel loader (Figure 3) that had been purchased by the DGS the previous year. The articulated four-wheel drive loader weighed about thirteen tons. It was equipped with an audible backup alarm and strobe lights that flashed during backing. At the time of the incident, both the audible alarm and the strobe lights were working properly. The loader had a right rearview mirror inside the cabin, and originally had exterior side-rear view mirrors on both sides. The two exterior mirrors had been broken off by tree branches during a snowstorm in December 2003 and had not been replaced. On the right side, the operator had virtually no blind spot due to a right interior rear view mirror. However, with the left exterior mirror missing, the

operator's blind spot on the left side extended back from the left rear of the vehicle approximately nine feet.

The loader that was operated by Operator A had been evaluated by the equipment dealer after 448 hours of service in December 2003. The dealer noted in the Comments/Summary section of the evaluation form that all operation and safety functions (of the loader) operated and performed properly. The dealer then indicated in the second page of the evaluation form that the mirrors and a broken light needed to be replaced. The broken light was replaced by the dealer at the time of the evaluation. The mirrors however were not replaced until ten days after the fatal incident. Both the DGS management representative and Operator A stated that they were not aware of the missing mirrors until the post-incident investigation.

Recommendation #2: *DGS facilities should repair damaged equipment in a timely manner.*

Discussion: If a piece of equipment becomes damaged or malfunctions, it should be removed from service until it is repaired. In this case the rear view mirrors that were broken off during a December snowstorm were not replaced until January 23rd, ten days after the incident. Although the missing mirrors in this case may or may not have directly contributed to the incident, they did create a blind spot for the driver on the left side of the vehicle.

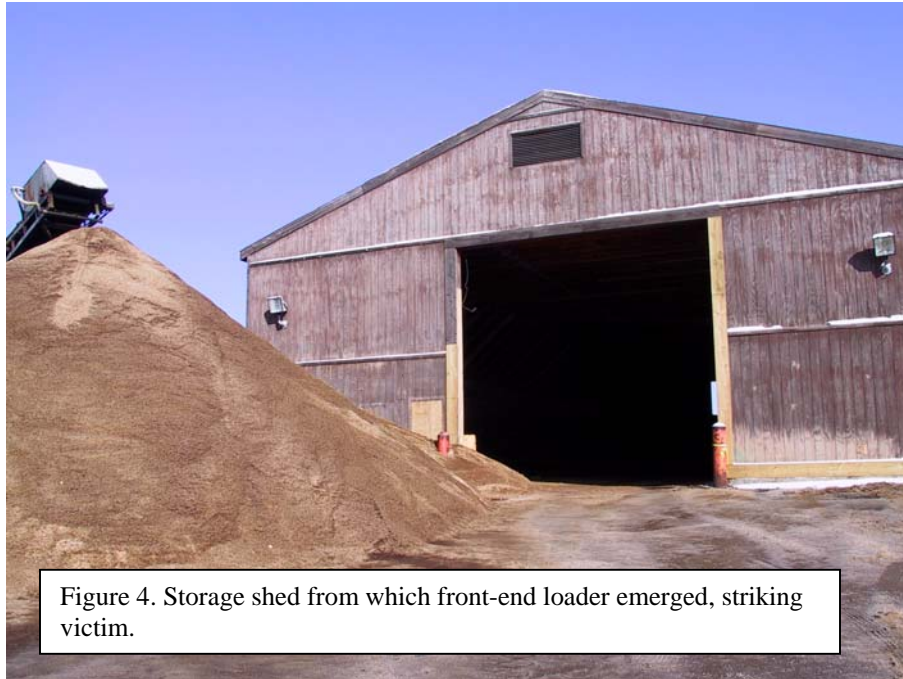
Figure 4. Storage shed from which front-end loader emerged, striking victim.

Just prior to the incident, one EO was working at the in-feed end of the mixer and another was fueling his loader at a gas pump at the other end of the salt yard. Neither of these EOs saw the incident. At approximately 3:50 p.m., Operator A began backing his loader out of the shed after dumping a load of salt (Appendix A). The loader backed 48 feet inside the shed to the shed entrance and then proceeded to back 41 feet outside the shed. Operator A stated that he looked back, left and right before and during backing, but did not see the victim in his path. As he backed along the side of the salt pile, Operator A felt the loader rocking as if it had run over a pile of salt. Realizing that he had just cleared the area and there should not have been any obstruction, Operator A immediately stopped the loader. He looked down at the left side and saw the victim's legs under the left front tire. It appeared that the victim was struck from behind while he was walking south around the treated salt pile. Operator A pulled the loader forward to get the front tire off the victim, set the brake on the loader, got out and called 911 on his cell phone immediately. He then ran to the other two operators to draw their attention. Both operators jumped out of their loaders, ran to the victim and stayed with him. EMT arrived on the scene within five minutes. The victim was transported to a local hospital where he was pronounced dead.
