FATALITY ASSESSMENT AND CONTROL EVALUATION

Worker Dies after Falling through a Steel Grid Plate into an Underground Frozen Coal Cracker Case Report: 03NY006

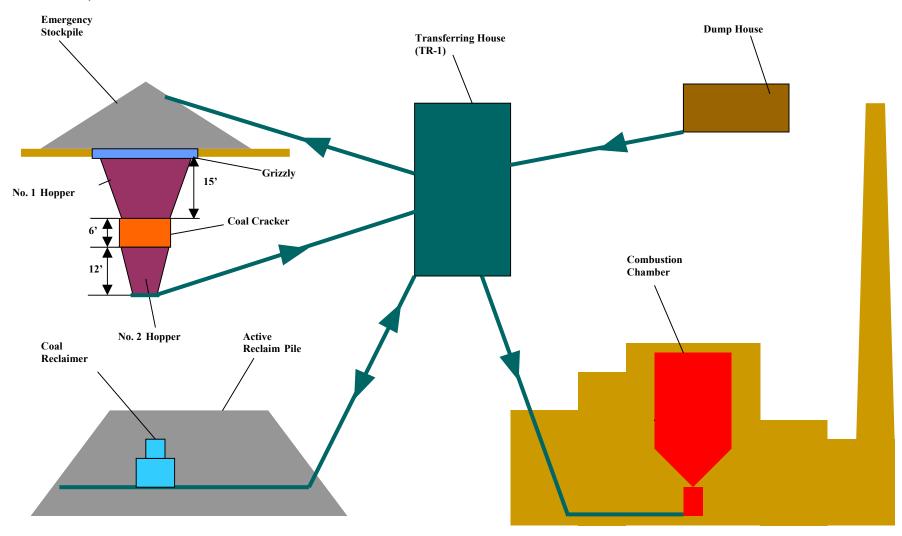
Figure 1. Illustration of the coal handling system in the coal-fired generating plant (The arrows demonstrate the coal moving directions).

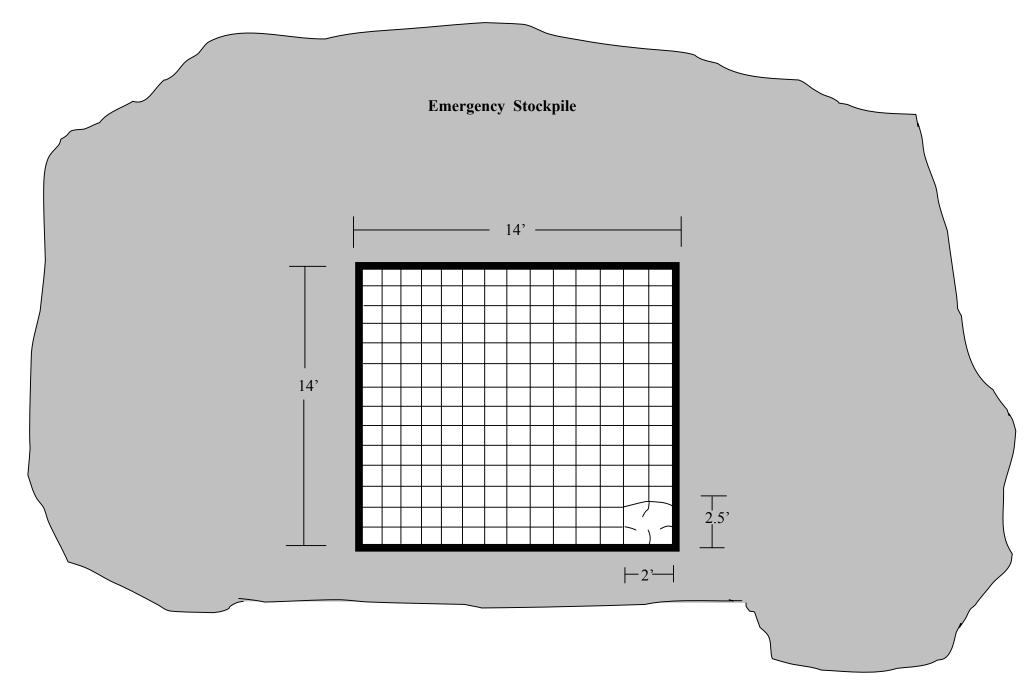
The last time the emergency stockpile had been used before the fatal incident was on January 22nd. On that day, damage to the grizzly was recorded in the team's daily log. The steel bars (1"X10") that formed the grids were broken and bent in one corner of the grizzly, resulting in a 2' by 2.5' hole. The team leader and the maintenance crew assessed the damage and decided to delay repairing the grizzly until spring, when the weather became warmer. According to the union steward, the majority of the team, including the victim, was verbally informed of the damage and the decision to delay the repair job.

Figure 2. Overhead view of grizzly. (Drawing not to scale).

Recommendation #1: Employers should repair damaged equipment in a timely manner, and place warning signs and guards immediately on and around the damaged equipment to warn workers of the safety hazard.

Discussion: In the event a piece of equipment becomes damaged or malfunctions, the equipment should be removed from service and repairs should be done immediately if the damaged equipment presents a safety hazard to the operator or other employees who work in the same area. If the damaged equipment cannot be removed from service or the repairs cannot be done immediately,

guardrails should be placed around the equipment, covers over fall hazards, and warning signs posted to warn workers of the safety hazards.
