Equipment Operator Killed by a Lock Ring Propelled from a Multi-piece Rim Wheel

Case Report: 07NY137

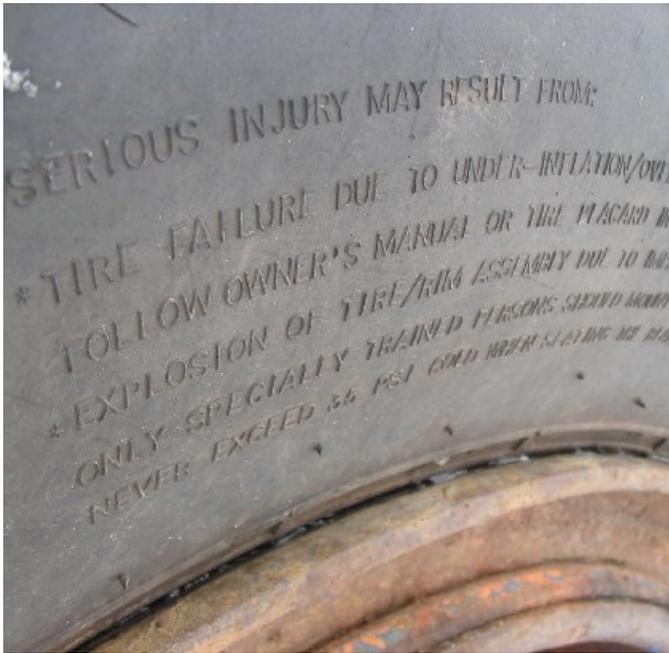
The victim operated a front-end loader that was a 1985 model. The loader was equipped with four pneumatic tires, size 17.5-25. The tires were 12 ply, load range F and equipped with tubes. The manufacturer specified 35 pounds per square inch (psi) as the maximum cold tire inflation pressure. The hazard warning on the tire stated that serious injury may result from under-inflating, overloading or improperly mounting a tire and that "only specially trained persons should mount tires"(Photo 1).

Photo 1. The warning on the tire addressing the hazards associated with under-inflating, overloading and improper mounting a tire (Photo courtesy of OSHA).

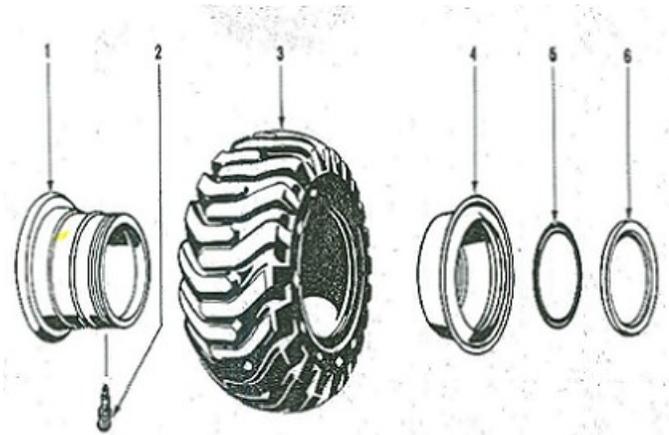
Three of the four tires, including the one that was involved in the incident, were mounted on wheels that were multi-piece type or split wheels. The multi-piece rim wheel in this case consisted of six components: the rim base, valve assembly, tire, side ring, O-ring and lock ring (Figure 1). The function of the lock ring was to hold the tire in place by locking and securing the other wheel components when the tire is inflated. The multi-piece rim wheel involved in the incident was installed in August 2006.

Figure 1. Components of the multi-piece rim wheel: 1. rim base, 2. valve assembly, 3. tire, 4. side ring, 5. O ring, and 6. lock ring (figure courtesy of OSHA).

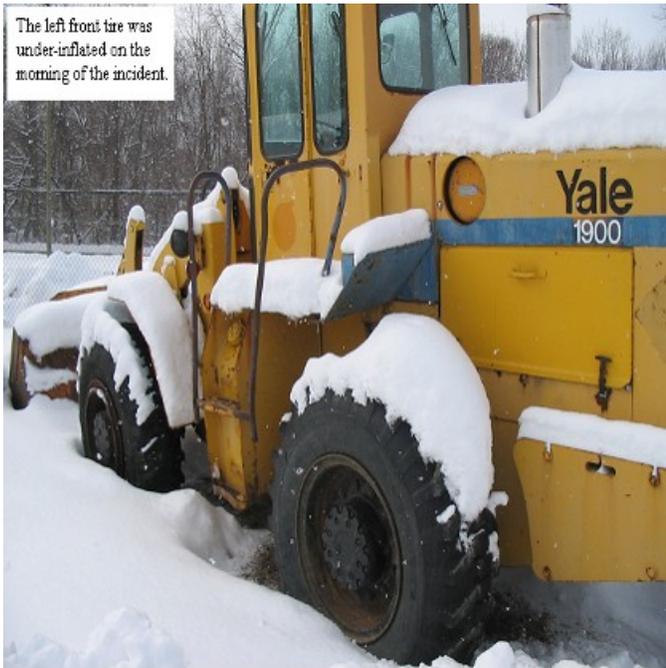
Photo 2. The loader that was operated by the victim on the morning of the incident. The left front tire was under-inflated at the time of the incident. (Photo courtesy of OSHA)

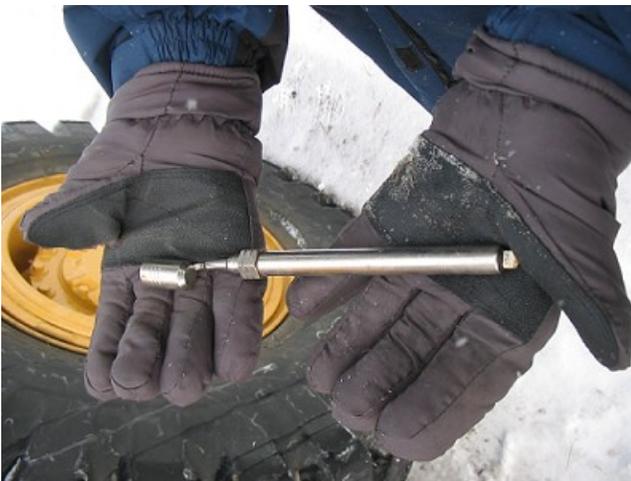
to warm up, the co-worker backed his loader over to the victim's loader and retrieved an air hose from his cab. The air hose was approximately 25 feet long and half-inch in diameter with a clip-on chuck on one end (Photo 3). It did not have an in-line pressure gauge. The co-worker connected one end of the air hose to the quick-connect fitting of the air compressor on his loader. According to the coworker, the victim was having trouble attaching the clip-on chuck to the tire valve stem. The co-worker attached the chuck to the tire valve for the victim. He then returned to his loader's cab and used the throttle control to maintain the airflow.

Photo 3. The air hose that was used by the victim and the co-worker during the incident. The hose had a clip-on chuck on one end. It did not have an in-line gauge (Photo courtesy of OSHA).

Recommendation #3: *Employers should provide an air hose that has an in-line pressure gauge and sufficient hose length between the in-line pressure gauge and the clip-on chuck to allow workers to stay outside the trajectory of the wheel components when inflating the tire.*

Discussion: Employers should provide every field equipment operator who may inflate a multi-piece rim wheel an air line assembly consisting of the following components: a clip-on chuck, an in-line valve with a pressure gauge or a pre-settable regulator and a sufficient length of hose between the clip-on chuck and the in-line gauge. Remote control inflation equipment may also be provided. All of this equipment enables the workers to stay outside the trajectory that propelled wheel parts may travel when inflating the tire.

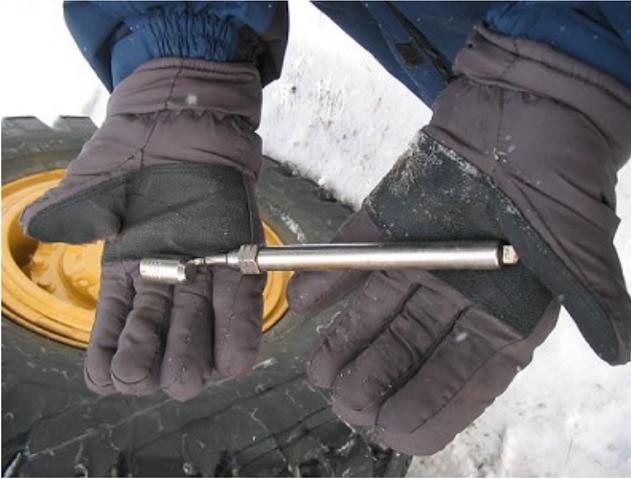
The initial tire pressure was not checked. Periodically, as the tire was being inflated, the victim checked the air pressure at the tire valve with a hand-held pressure gauge (Photo 4). According to the co-worker, the victim informed the co-worker that the air pressure in the tire was about 15 to 20 psi after a few minutes of injecting air into the tire. This was well below 28 psi, that was 80% of the

Photo 4. The hand-held air pressure gauge used by the victim during the incident (Photo courtesy of OHSA).

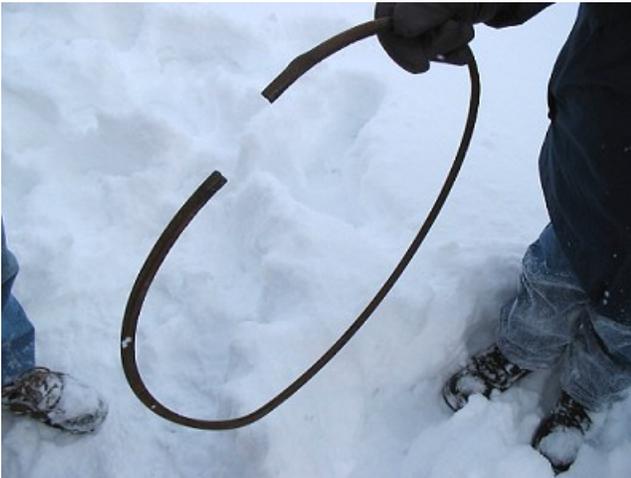
Photo 5. The lock ring that was propelled from the multi-piece rim wheel; it struck the victim while he was inflating the rim wheel (Photo courtesy of OSHA).

If a tire mounted on multi-piece wheel loses a significant amount of air, the wheel components that are secured in the rim base under the normal tire air pressure may be offset or dislodged. When the flat tire is inflated, due to the rapid increase of the air pressure and volume, the dislodged wheel components can be propelled at great distances with great forces and can cause serious injury or death to anyone in the trajectory area. The victim and the co-worker in this case apparently were not aware of the danger of inflating a multi-piece rim wheel.

Recommendation #1: *Employers should develop, implement and enforce a SOP for inflating multi-piece rim wheels that requires that only trained workers service or inflate multi-piece rim wheels.*

OSHA requires that if the pressure in a multi-piece rim wheel is reduced to 80% or below the recommended operating pressure, the tire assembly shall be completely deflated, removed from the vehicle, disassembled, inspected and reassembled prior to inflation. These should only be done by professional tire services. Maintenance personnel or equipment operators should never attempt to perform the job in the shop or the field.

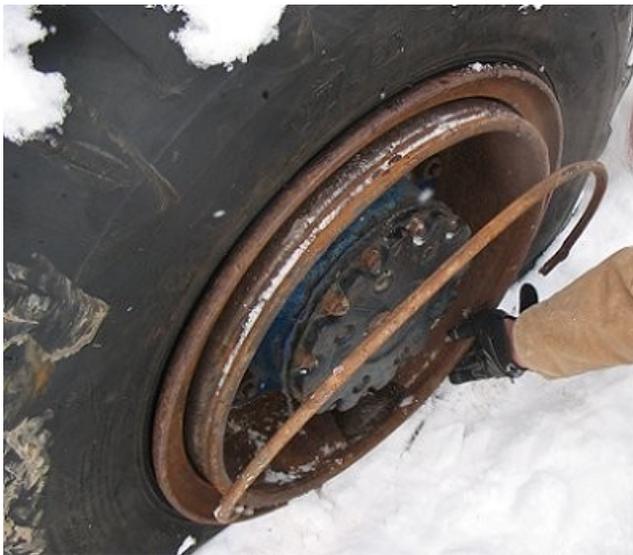
Photo 6. The dislodged lock ring was being refitted to the multi-piece wheel that was involved in the incident (Photo courtesy of OSHA).
