FATALITY ASSESSMENT AND CONTROL EVALUATION

Contractor Crushed against the Cab of a Dump Truck by the Dump Body Case Report 08NY067

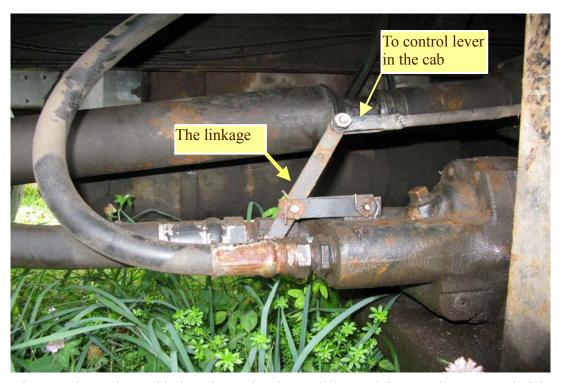
Photo 2. The mechanical linkage located underneath the truck frame. The upper end of the linkage was connected to the control lever in the cab through a horizontal bar. The lower end (not visible) was connected to the dump body cylinder valve.
