FATALITY ASSESSMENT AND CONTROL EVALUATION

Mechanic Electrocuted when a Mobile Light Tower Contacted Powerline Case Report 12NY018

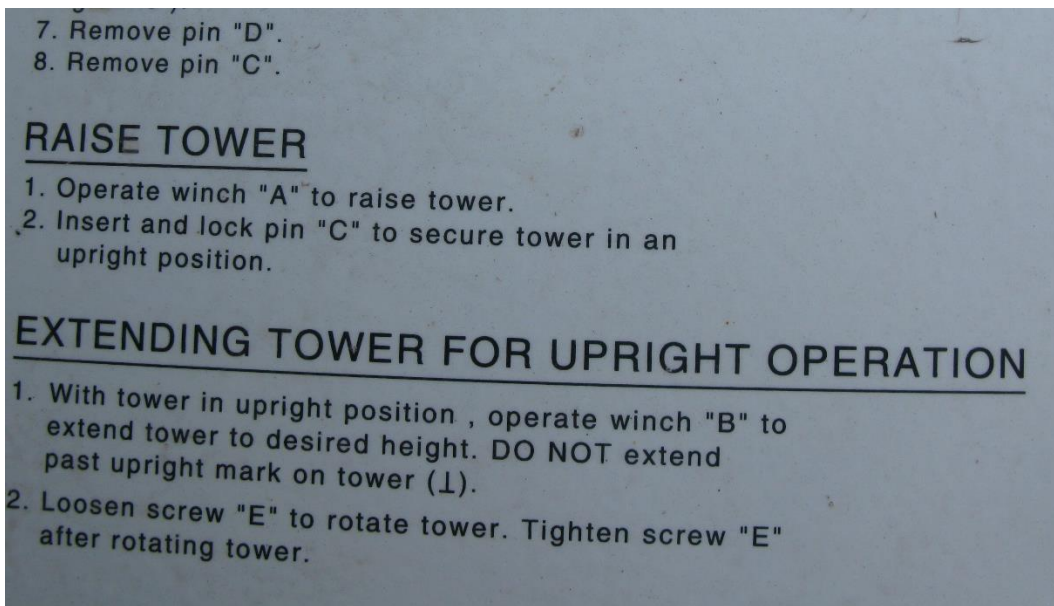
Photo 5. The Operating Instruction posted on the tower did not specify which direction to turn the winches to raise or extend the tower.

Discussion: The operating manual and the operating instruction posted on the tower in this case did not state the specific directions (clockwise or counter clockwise) to crank the winches for extending or

Recommendation #6: *Manufacturers should provide clear and specific instructions in operating manual on how to raise and lower a light tower.*

retracting the light tower. Manufacturers should provide clear instructions on which direction raises or lowers the tower.
