FATALITY ASSESSMENT AND CONTROL EVALUATION

Truck Driver Fatally Struck When Fencing Materials Fell from Flatbed Trailer During Unloading (Case #: 17NY014)

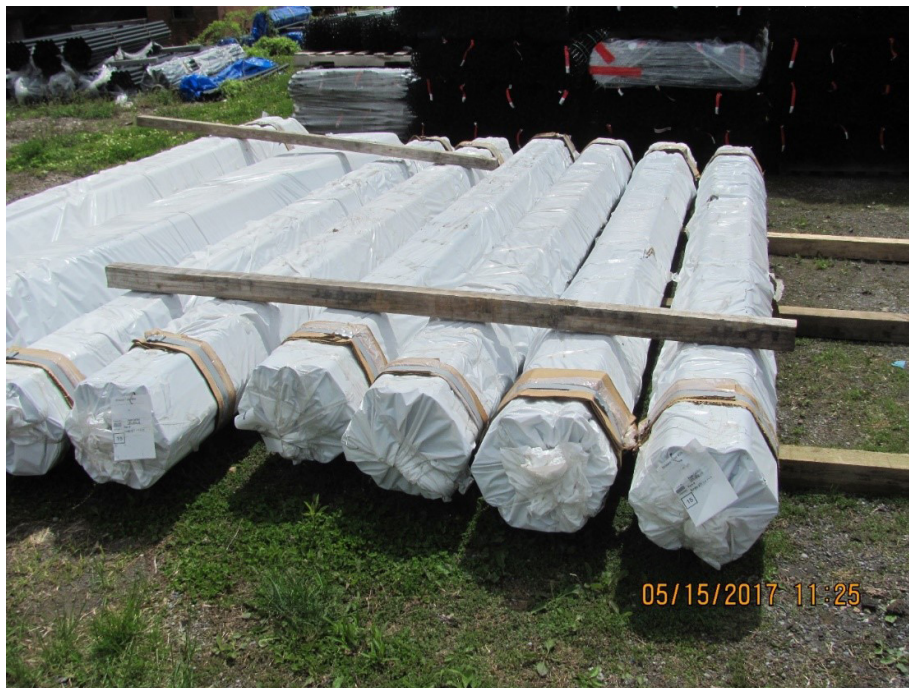
Photo 3. One of these hexagonal fence pipe bundles wrapped in plastic, 14 ft long and 1,400 pounds in weight, fell from the flatbed trailer and fatally struck the truck driver (photo courtesy of OSHA).
