FATALITY ASSESSMENT AND CONTROL EVALUATION

Equipment Operator Killed when Pinned to a Tree by an Excavator Case Report: 06NY010

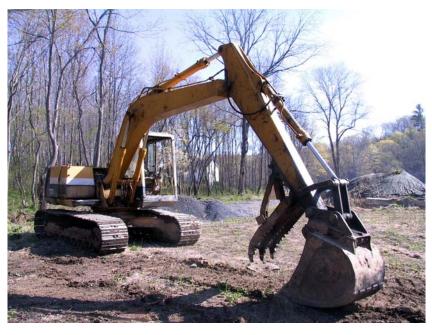
Photo 1. The hydraulic excavator that was involved in the incident.

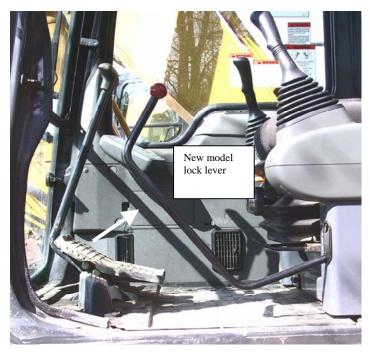
Photo 4. The lock bar in newer model excavators blocks the cab door path when in the unlock position.
