FATALITY ASSESSMENT AND CONTROL EVALUATION

Town sanitation worker fatally crushed while riding on the riding step of a refuse collection truck
Case #: 18NY063

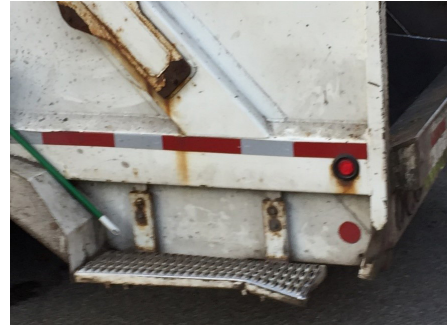
The manufacturer required that the operators inspect the riding steps before each use to make sure that they are in good working condition. Operators are to keep the steps free of all debris, grease, or slick material. The manufacturer also stated that no one should ever ride on the steps if the steps are damaged, bent or broken. The step on the driver’s side on this truck was bent (photo 2).

Photo 2. The warning sign on the refuse collection truck was faded with illegible wording (Courtesy of PESH).

***Discussion:*** The refuse collection truck that was involved in the incident had a riding step that was bent. According to the OSHA fatality investigation records, sanitation workers have suffered fatal injuries from falling or slipping off riding steps that were bent or damaged. Manufacturers prohibited operators from riding on the steps that are damaged, bent, or broken and required operators to keep the steps free of all debris, grease, or slick material. Employers should ensure that the riding steps are regularly inspected to make sure that there is no damage to the steps and that attachment is secure. Vehicles with damaged steps should be removed from service, and the damaged steps should be repaired or replaced in a timely manner.

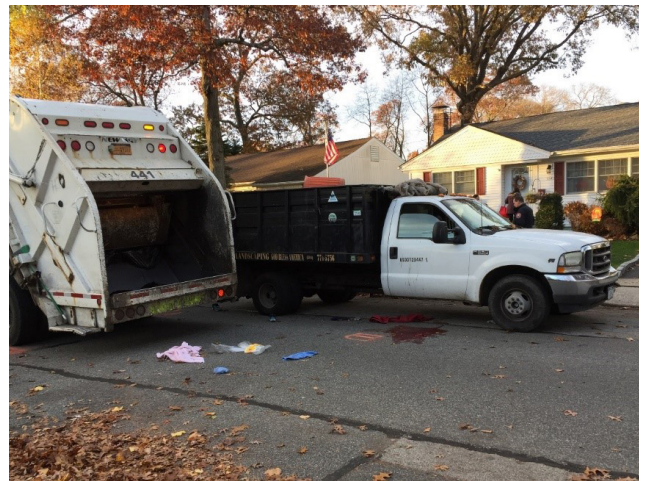
The driver continued backing and felt his truck contact the lawn service truck. He stopped and drove forward to pull his truck away. According to the eyewitness, the victim was pinned and crushed in between the lawn service truck and the refuse collection truck. As the refuse collection truck pulled away, the decedent fell to the ground, and he was subsequently run over by the rear passenger side tire of the refuse collection truck. The crew member immediately called 911 and the Emergency Medical Services responded within minutes. The injured worker died on route to the hospital.

Photo 3. The victim was crushed against the lawn service truck while riding the refuse collection truck on the right riding step when the refuse collection truck was backing up (Courtesy of PESH).

**Recommendation #1:** Employers should consider prohibiting the practice of riding refuse collection truck riding steps by removing these steps.

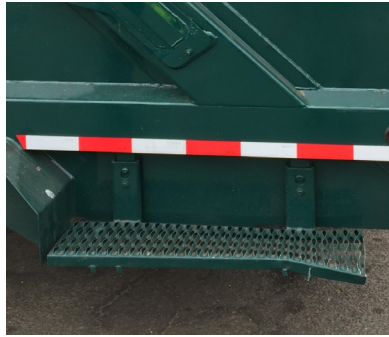
PESH conducted a follow up inspection in February 2020, 15 months after the fatal incident. The garbage truck that was involved in the incident was painted and fitted with a new compactor. The old illegible warning sign on the truck was replaced. However, the bent step was still not repaired (Photo 4).

Photo 4. Fifteen months after the fatal incident, the refuse collection truck that was involved in the incident was painted and fitted with a new compactor. The bent step was still not repaired (Courtesy of PESH).

***Recommendation #6: Employers should ensure that the riding steps are inspected regularly, and damaged steps are repaired immediately.***
