## FATALITY ASSESSMENT AND CONTROL EVALUATION

**A Plumber Dies After the  
Collapse of a Trench Wall  
Case Report: 07NY033****SUMMARY**

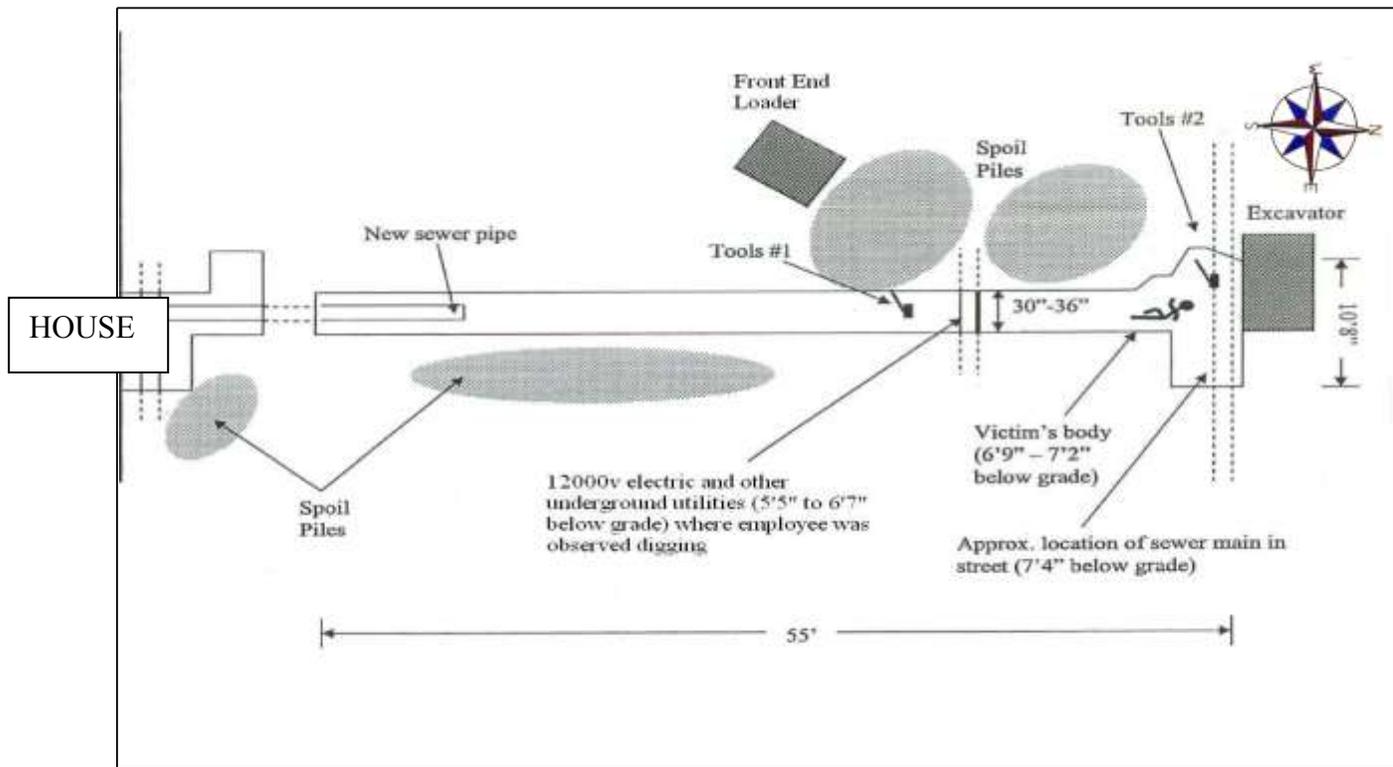
The GC left the work site to purchase the correct parts, while the excavation continued. The dimensions of the final trench were approximately 55 feet in length, 3 feet to 8 feet in depth, and 30 inches to 128 inches in width (see Figure 1). It was shaped like a "T." The gravity sewer main that the victim was connecting to was located at a depth of 7 feet 4 inches (7' 4") below grade at the east (E) end of the top of the "T." Installation of new sewer pipe from the residence had been initiated and some of the trench had already been backfilled. The length of the trench from the top of the "T" to the location of the newly installed sewer pipe was 35 feet 11 inches (35'11") at the time of the incident. Soil analysis results, conducted after the incident, indicated a granular, sandy gravel Type C soil (OSHA Excavation Standard) that contained large cobbles and boulders, the least stable soil type.

Figure 1: Schematic of the excavation and the incident site (courtesy of OSHA)

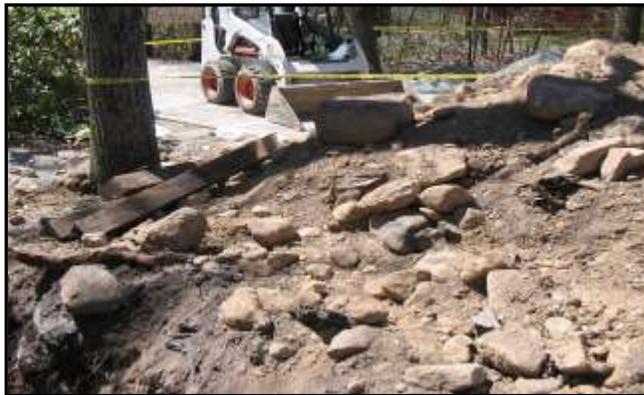
The faces of the trench were vertical. No shoring or benching was used. Large cobbles and boulders and loose rock/dirt were visible on the face of the excavation and were not removed or supported. The pavement above the E and W faces of the excavation had been undermined during excavation activities and no support system was utilized to protect employees from a possible collapse. Pieces of road pavement and asphalt had been undermined during excavation activities in the road in the proximity of the sewer main at the top of the “T.” These areas were in plain view and did not have additional support. On the W side of the excavation, loose boulders, rock and debris in spoils piles were located less than two feet from the edge of the trench. (Figure 2) The excavator was positioned adjacent to the N end of the trench, where undermined areas were in plain sight. The N end of the trench, where the victim was installing the sewer tap, also lacked an access ladder or other safe means of entry/egress.

Figure 2: View of the west wall of the excavation south of the “T.” Note the boulders and loose rock/dirt on the excavation face as well as the location of the spoils pile within 2 feet of the edge of the trench. (courtesy of OSHA)

**Recommendation #1:** *Employers and independent contractors should require that all employees, subcontractors and site workers working in trenches five feet or more in depth are protected from cave-ins by an adequate protection system.*

**Discussion:** Employers and contractors should require that all employees working in trenches five feet deep or more are protected from cave-ins by an adequate protection system appropriate to the conditions of the trench, including sloping techniques or support systems such as shoring or trench boxes (OSHA 29CFR 1926.652). Sloping involves positioning the soil away from an excavation trench at an angle that would prevent the soil from caving into the trench. Even in shallow trenches less than five feet in depth, the possibility of accidents still exists. Trenches five feet deep or less should also be protected if a competent person identifies a cave-in potential. Trench protection systems are available to all employers and independent contractors, even as rental equipment. Employers should also require that all pieces of excavated pavement, asphalt, dirt, rock, boulders, and debris as well as excavation equipment are located in spoils piles or positions that are at least two feet from the edge of the excavated trench. Where a two foot setback is not possible, spoils may need to be hauled to another location. In this incident, sloping would not have been an appropriate protection system, due to the composition of the soil. Employers and contractors should consult tables located in the appendices of the OSHA Excavation Standard that detail the protection required based upon the soil type and environmental conditions present at a work site. Employers and contractors can also consult with manufacturers of protective systems to obtain detailed guidance for the appropriate use of protection systems.

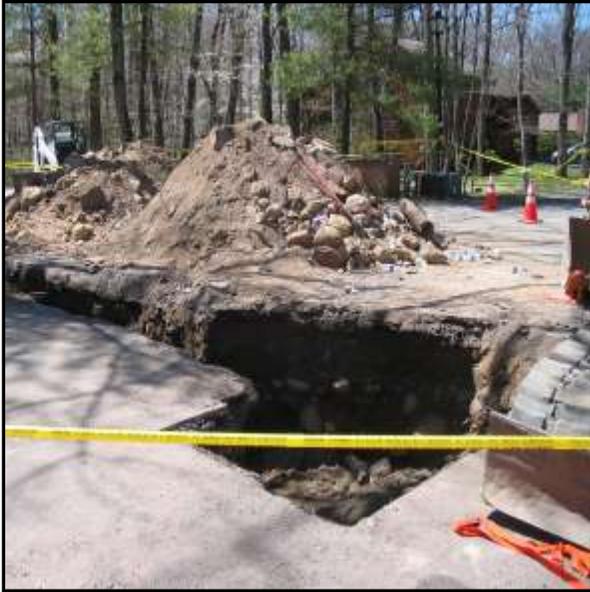
The OSHA investigation resulted in findings that the trench section that collapsed was a triangular shaped area at the northwest corner of the excavation, approximately 5 feet 1 inch (5' 1”) in length, 4 feet (4') wide, and 6-7 feet (6-7') deep. Multiple hazards were present, but had not been identified and remediated. The W side of the excavation collapsed and pieces of asphalt paving and rock fatally crushed the victim while he was making the sewer tap (Figures 3 and 4).

*Figure 3: Location of collapse.  
Note spoils piles and equipment located less  
2 feet from the edge of the trench  
(courtesy of OSHA)*

**Recommendation #2:** *Employers and independent contractors should require that a competent person conducts daily inspections of the excavations, adjacent areas, and protective systems and takes appropriate measures necessary to protect workers.*

**Discussion:** Employers and independent contractors are responsible for complying with the OSHA Excavation Standard requirements to designate a competent person on site for excavation and trenching projects to make daily inspections of excavations, the adjacent areas, and protective systems (OSHA 29CFR 1926.651). A competent person is defined as someone who is capable of identifying existing and predictable hazards in the surroundings and working conditions that are dangerous to employees and who has the authorization to take prompt corrective measures to eliminate them. They should inspect the trenches daily, as needed throughout the work shift, and as conditions change (for example, heavy rainfall or increased traffic vibrations). These inspections should be conducted before worker entry, to ensure that there is no evidence of a possible cave-in, failure of a protective system, hazardous conditions such as spoils piles or equipment location, or hazardous atmosphere.

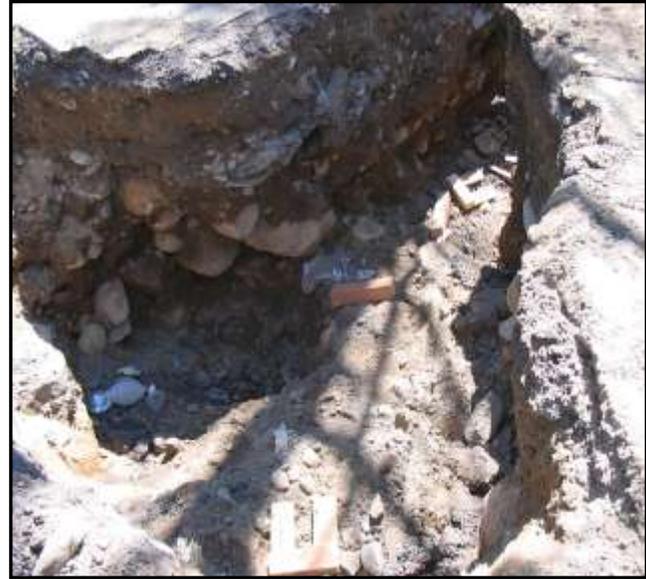
*Figure 4: Area of trench collapse  
Note the large boulders hanging from the  
excavation faces and undermined areas on the  
edge of the trench (courtesy of OSHA)*

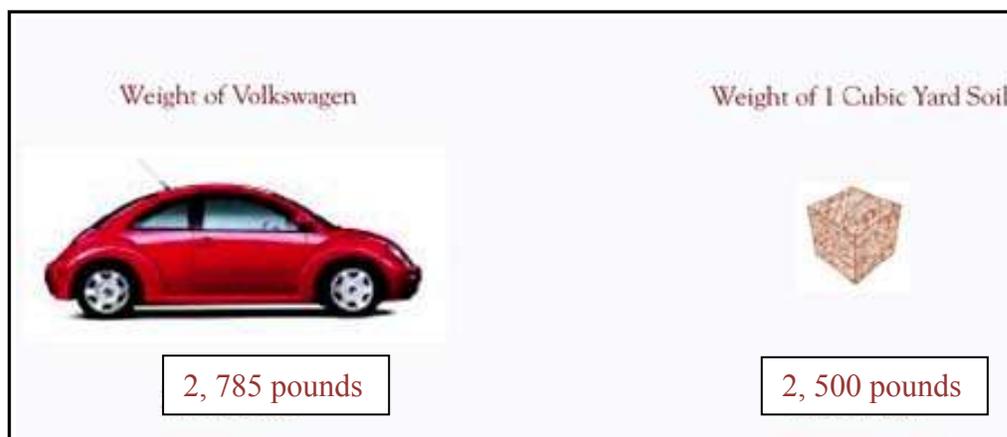
The key to preventing a trench accident is not to enter an unprotected trench. When the walls of a trench collapse or cave in, the results are entrapment or struck-by incidents to anyone caught inside, accidents which can occur in seconds. Many workers in a trench are in a kneeling or squatting position that results in little opportunity for an escape. Victims do not need to be completely covered in soil. Even with partial covering, enough pressure is created for mechanical asphyxia in which the weight of the dirt and soil compresses the chest. One cubic yard of soil has an average weight of 2500 pounds (Figure 4), but can vary due to the composition and moisture content.

Figure 5: Weight of one cubic yard of soil (courtesy of “Weights of Building Materials, Agricultural Commodities, and Floor Loads for Buildings” standard reference)
