FATALITY ASSESSMENT AND CONTROL EVALUATION

Part-Time Farm Worker Dies During Tractor Overturn Case Report: 02NY023

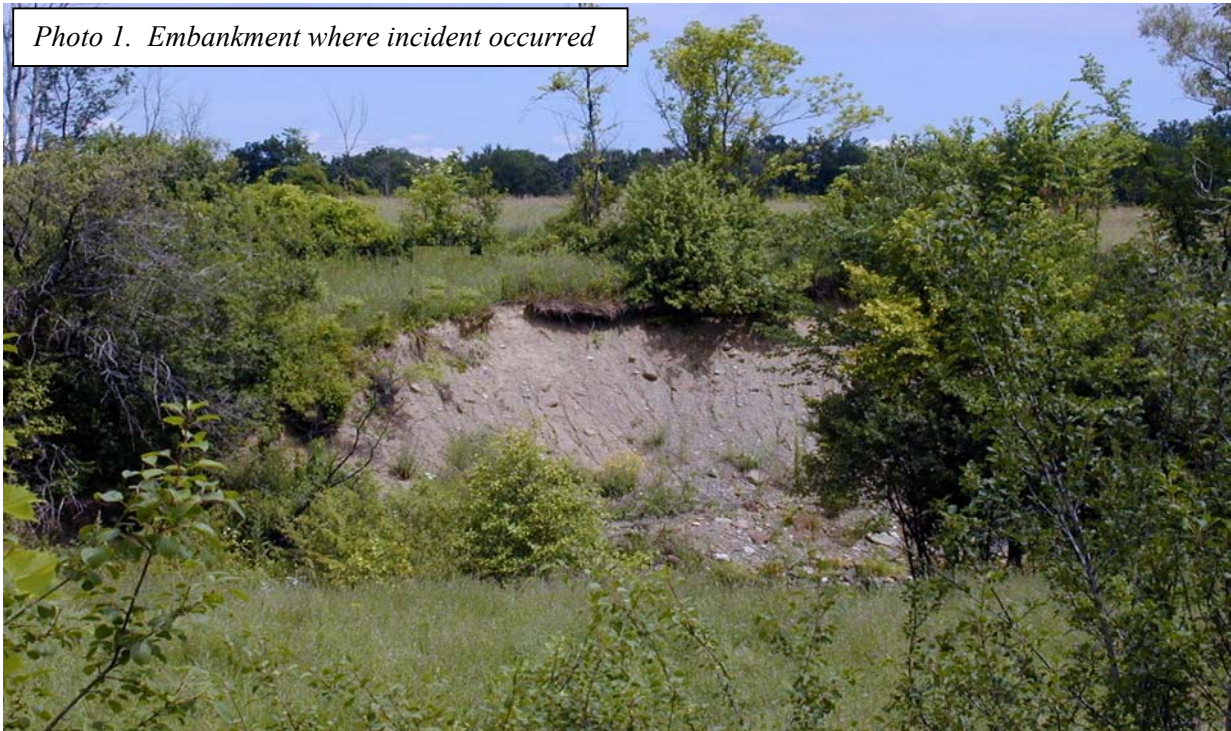
At approximately 1:00 pm, the farm worker was brush-hogging up a side hill at the edge of the pasture and had made one pass up a farm lane to the top of the hill and returned to the bottom. He then turned around and was brush-hogging an adjacent six foot wide path next to the original pass. As he neared the top of the slope, he attempted to turn the tractor around in a loop configuration to return down the hill. As he turned to the right, the right side of his tractor came dangerously close to a thirty-five foot drop embankment that descended at a 75 degree angle (*see Photo 1*). This embankment had been created by erosion from the nearby stream that was located at the bottom of the embankment. Over time the stream had eroded the steep bank, resulting in the bank being cut back in towards the pasture slope. There was no vegetation growing on this cut-away embankment, and in fact the erosion had caused the embankment to be cut back underneath the overhang of the vegetation at the top. As the tractor's right front tire passed over the overhang, the overhang gave way allowing the soil to crumble down the embankment. The right front of the tractor fell down over the embankment pulling the tractor and brush-hog down in a forward and right roll direction. The tractor immediately rolled as it proceeded down this steep embankment and effected a complete 360 degree turn, rolling over on its right side, crushing the operator, and then continuing to roll until it ended right side up in the streambed itself.

Photo 1. Embankment where incident occurred

It appeared that as the tractor overturned down the bank, the operator remained in the operator's seat location. There was no rollover protective structure on the tractor or any other type of cab. Therefore, as the tractor overturned the operator was crushed between the left rear fender of the tractor, which was immediately adjacent to the operator's seat and the ground. This scenario would make sense since the tractor was rolling to the right and the operator would have a tendency to lean to the left as the tractor was overturning. Upon overturn and contact with the ground, the operator's chest and back were crushed between the fender of the tractor and the ground. The ground at this location of overturn contained many large rocks and so there was no give in the ground surface as the tractor crushed the victim against this area. It is believed that the victim both misjudged the distance of usable ground on which he could drive and where the embankment started. Also, the fact that a few feet of ground gave way at the edge of the embankment contributed to the incident.

Discussion: In this scenario the worker did not fully recognize the hazards of the bank and the safe turning area in relation to the steep embankment. If he had inspected this area on foot prior to operation of the tractor within this area he would have seen the unsafe area before driving into that region.
