# STATE OF NEW YORK DEPARTMENT OF HEALTH

## FATALITY ASSESSMENT AND CONTROL EVALUATION

### Teenage Farm Worker Dies during Silage Defacer Entanglement Case Report: 05NY001

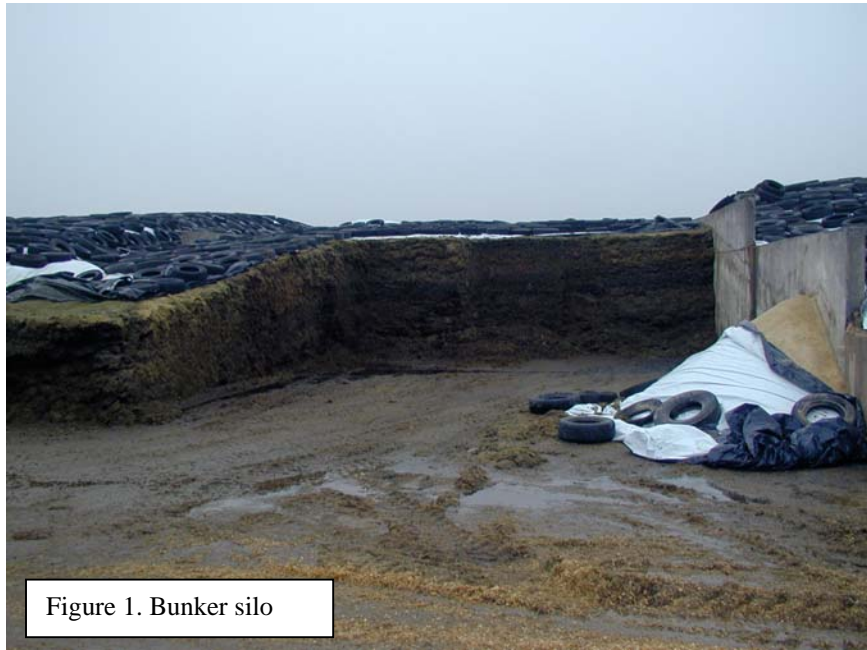
A bunker silo is a concrete structure that is set horizontally in the ground and has a concrete base and walls with an open top. Silage is placed and packed in this bunker, then covered with plastic until it is used. As it is used, the material is removed from the front of the silage bunker towards the back. The cover on the top of the bunker is moved back to the removal level of the silage (Figure 1). A payloader or a front-end loader on a tractor is commonly used on dairy farms to scoop up silage from the silage face and place it in a feed mixing wagon. A newer technology that farms have begun to use is a piece of equipment called a silage defacer. This unit attaches to either the front of a payloader or an agricultural tractor. Lift arms allow the defacing unit to be moved vertically up and down. The unit has large rotating wheels with teeth on them that remove a slice of silage. Typically, these teeth remove about 6 inches of material from the face vertically each time (Figure 2). The unit is placed in the uppermost position and shaves off a section of the silage face allowing the material to fall to the base of the silage bunker. A payloader then scoops the silage and places it in a feed mixing wagon. A defacer is used to allow a clean slice to be removed and a uniform face to be maintained, which prevents additional spoilage by reducing the surface area of silage exposed to the elements. Additionally, this reduces the potential for overhangs and unstable silage faces to form, which have been known to collapse and entrap workers.

Figure 1. Bunker silo

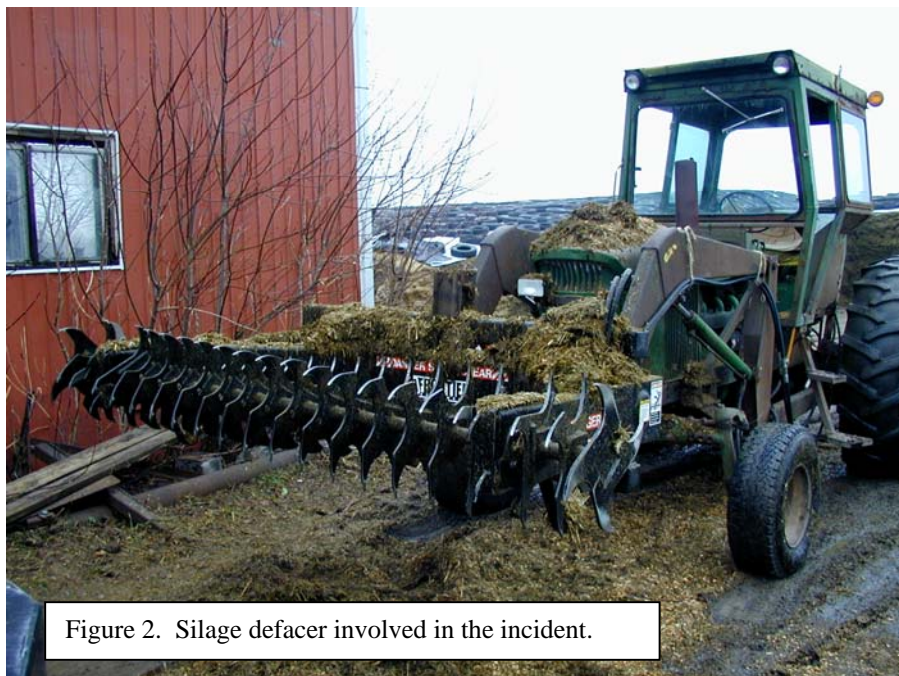
As the young worker began his chores on the morning of the incident, he started a John Deere 4020 tractor that had the front-end loader arms attached and a silage defacer mounted on the arms. The silage defacer was manufactured by Frontier Equipment Company and was approximately four years old. The farm had no previous safety or operational problems with this defacer, and it was properly marked with warning signs, warning operators to stand clear of the equipment (Figure 3).

Figure 2. Silage defacer involved in the incident.

As the tractor engine was warming up and the defacer unit was running, the victim dismounted the tractor and walked around in front of the unit. As he was going around the front right hand corner of the unit, the outside defacer wheel caught the right hand shoulder material of his jacket. When the teeth on the wheels caught the jacket material, the victim became entangled around the rotating defacer unit. The victim rotated around the unit and struck both the ground and the front fender of a Mac Aerodyne truck that was parked in front of the defacer unit.

**Discussion:** This particular piece of equipment has very aggressive blades similar to a circular saw blade that has large protruding metal teeth. This is necessary for the equipment to remove silage from a compacted state. Entanglement zones of this type should be avoided. The silage defacer involved in the incident had clear warning signs very visibly placed on the unit communicating to workers that they should stay clear of the unit.

**Discussion:** In this scenario, the victim had energized the unit, dismounted from the tractor, and then walked around the front of the defacer while the defacer's wheels were spinning. The victim then made inadvertent contact with an end wheel resulting in entanglement. The defacing wheels on this particular unit were painted black, a non-visual color when in motion. If the end wheels were painted red (or in combination with yellow striping) the color combination would be more visible when rotating, thereby making the equipment stand out and increasing the likelihood that it will be seen by workers.

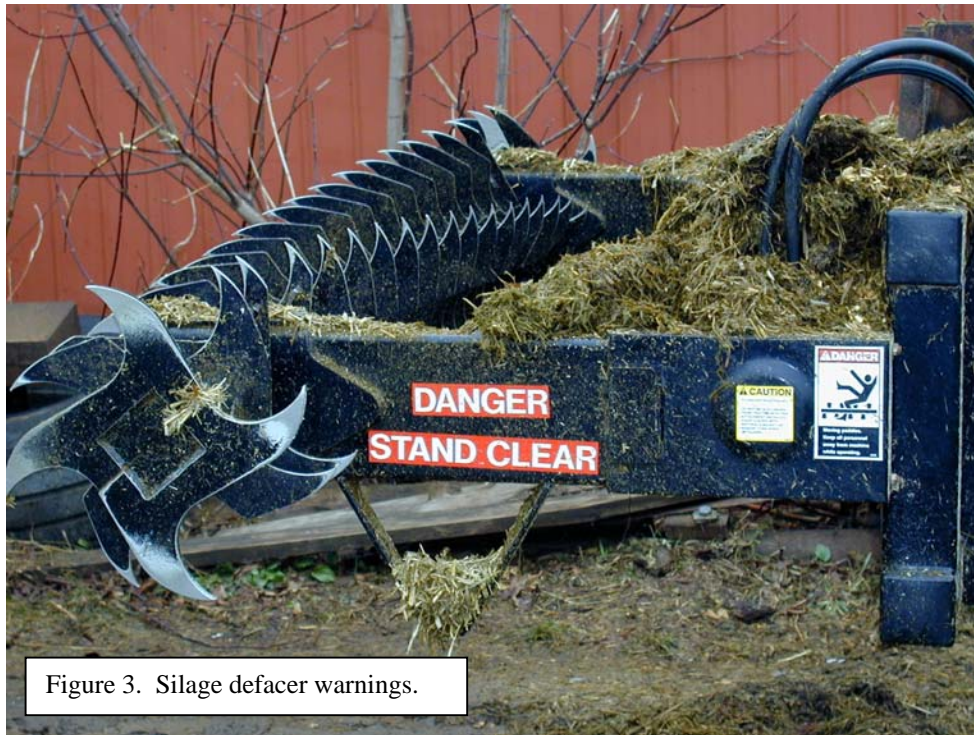
Figure 3. Silage defacer warnings.
