STATE OF NEW YORK DEPARTMENT OF HEALTH

FATALITY ASSESSMENT AND CONTROL EVALUATION

Worker Crushed by a Crate of Glass at a Residential Construction Site

Case Report: 06NY001

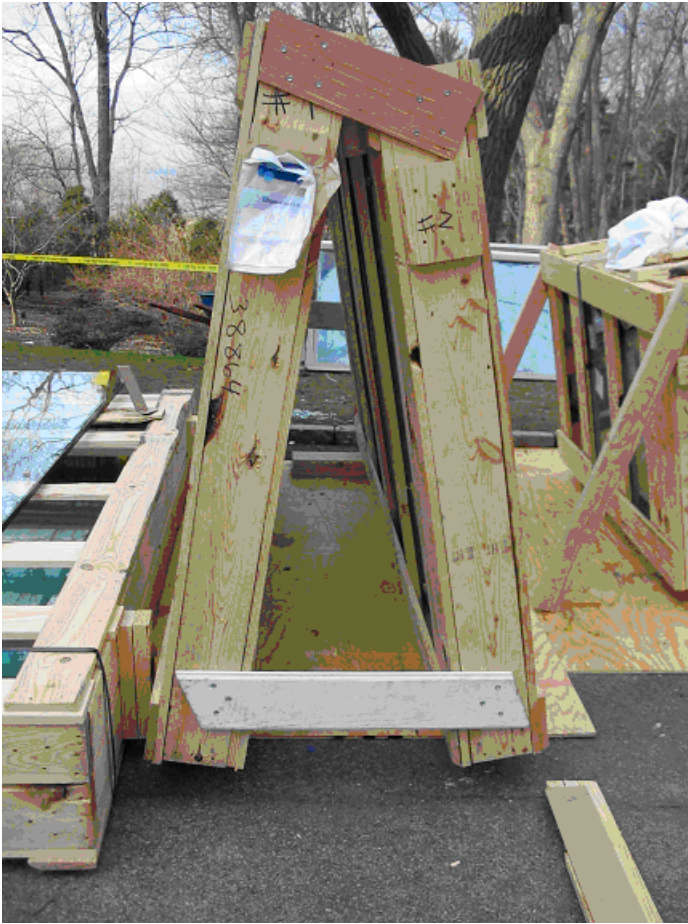
workers attached one wooden bar (re-enforcing brace) on the top end and another on the bottom end of the crate frame using a screw gun with 3 ¼” (inch) hex screws. The crane then unloaded the second large crate and placed it parallel to the first one. The workers tilted the two crates until their tops met and leaned on each other. The workers screwed the other ends of the two re-enforcing braces to the second crate to stabilize the “A” frame structure (Photo 1).

Photo 1 (courtesy of OSHA). The first “A” frame that was set up by the workers. The smaller crate supported by the two wooden bars is on the right.

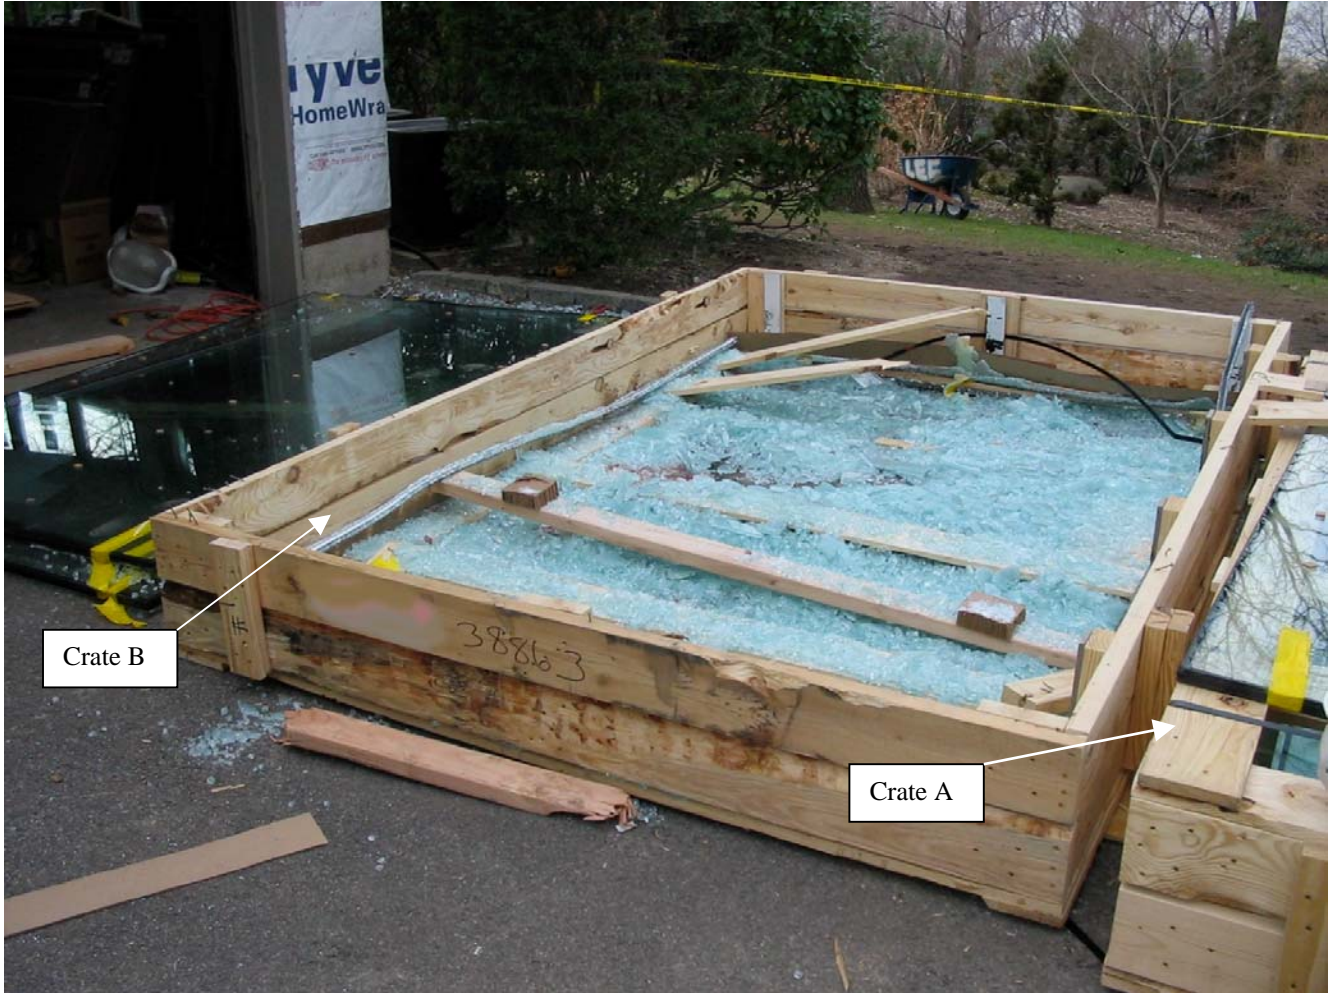
At the time of the incident, the foreman was standing at the north end of the two crates and the co-worker was at the south end. The victim was at the west side of the crates facing Crate B (Figure 1). The foreman directed the workers to push and tilt the crates toward each other. It was witnessed by other contractors working nearby that Crate A slowly overcame the weight of Crate B. Both crates started leaning toward the victim and fell over. The victim was crushed by Crate B (Photo 2). The foreman immediately called 911 to summon emergency medical services (EMS). EMS arrived at the site within minutes. The victim was pronounced dead at the scene.

Photo 2 (courtesy of OSHA). Crate B was overcome by Crate A, fell on the victim, and crushed him.

Recommendation #1: Employers should ensure that a crane is used to stage large and heavy crates of glass and keep the crates attached to the crane until they are stabilized and chocked.

Discussion: Once a crate of glass is tilted and supported either by wooden bars or by another crate of glass, the tilted crate should be chocked at its' base to prevent the crate from kicking back and collapsing. In case the crates are large and heavy as in this instance, workers may have to use multiple chocks. After the "A" frame is chocked, bracing bars should be attached to both sides of the frame to reinforce the structure.

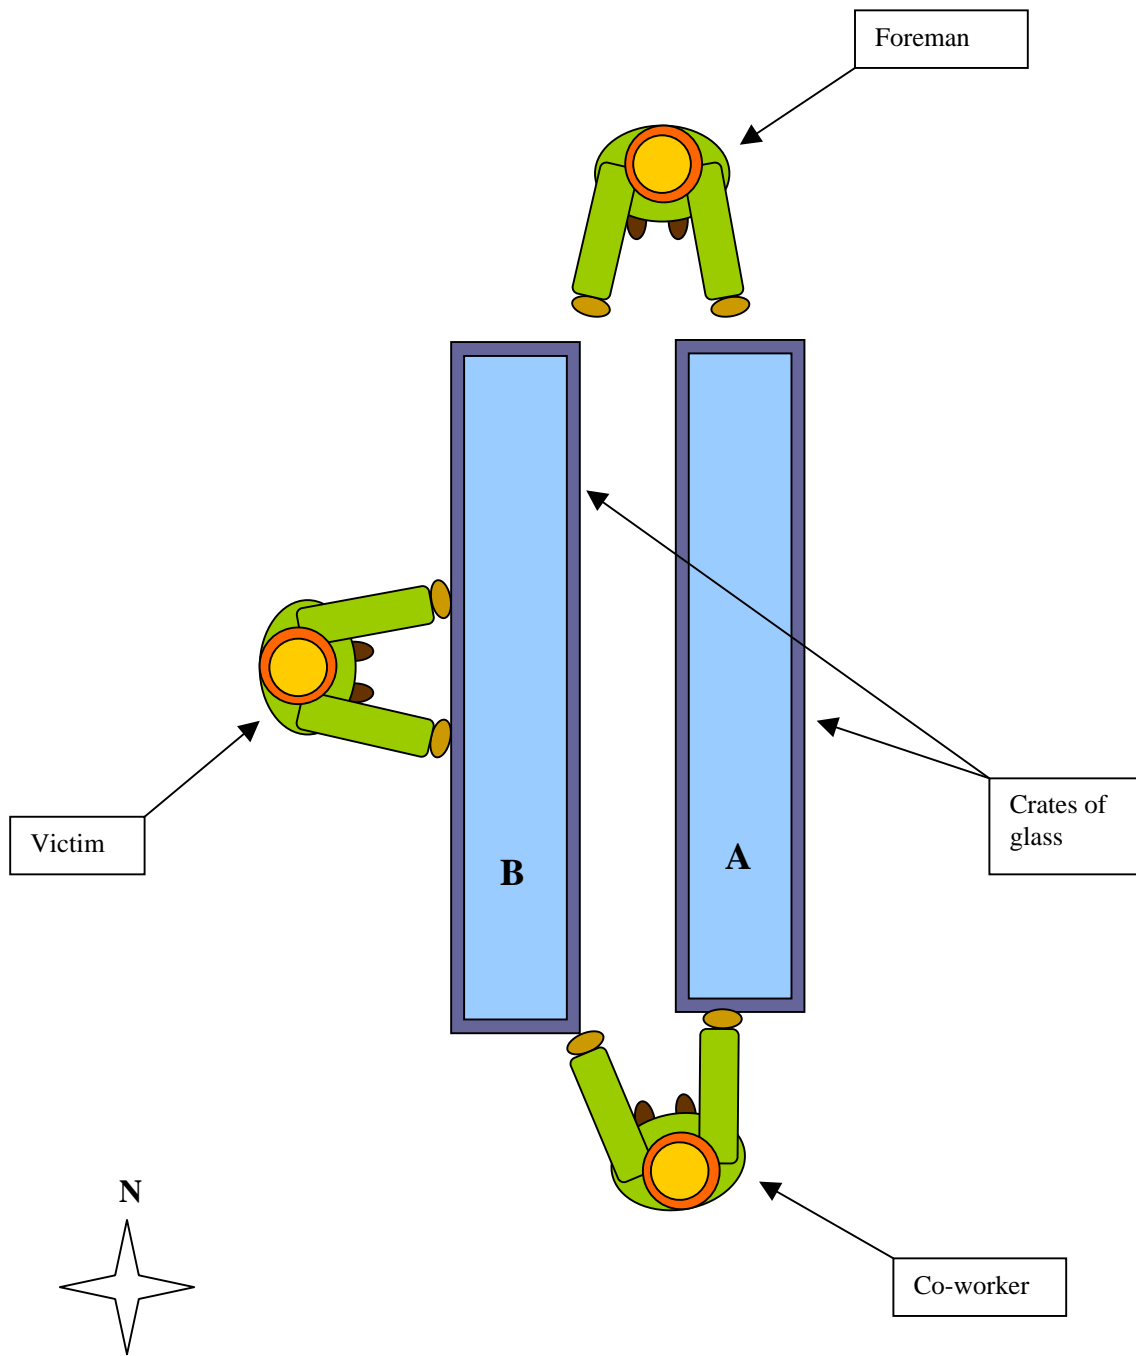
Figure 1. The positions of the victim and his co-workers and the two crates of glass.

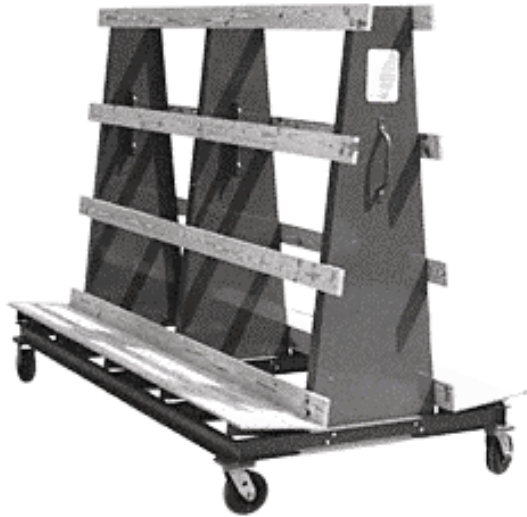
“A” frame carts (Photo 3) are available from material handling and fenestration equipment manufacturers. Currently these carts are mainly being used by the glass manufacturing industry. The “A” frame carts have angled supports and mechanisms to prevent loads from sliding and kicking back. With modification, it may be possible for the “A” frame carts to be used in construction sites and construction workers or glaziers could avoid manually tilting the crates. However, there are no standards or guidelines developed by American National Standards Institute (ANSI) or other standard setting bodies on designing, testing and using “A” frame carts. Manufacturers of the products should research and explore the possibility of safely adapting these devices for use at construction sites.

Photo 3. An example of “A” frame cart. *

Recommendation #5: *Manufacturers of "A" frame carts should research and explore the possibility of safely adapting these products for use in construction settings.*
