# STATE OF NEW YORK DEPARTMENT OF HEALTH

## FATALITY ASSESSMENT AND CONTROL EVALUATION

### Master stonemason dies in a 30-foot fall from a handmade work platform attached to a powered industrial truck Case Report: 07NY107

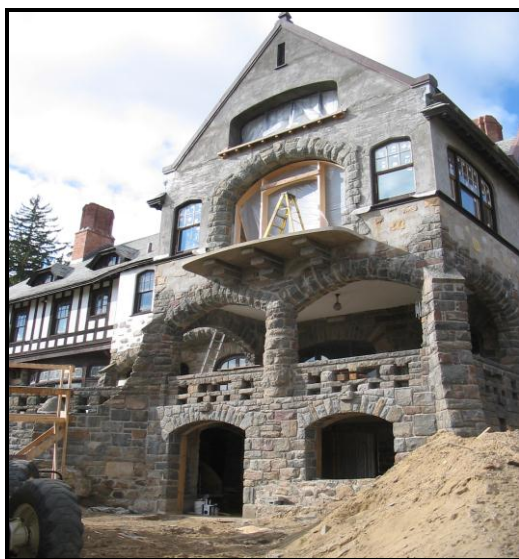
The renovation project included the construction of a second story addition at the northeast corner of a stone and masonry mansion (Photo 1). The terrain around the mansion was sloped and uneven; the rear side of the second story addition was 3 full floors above the ground level (Photo 2).

**Photo 1 Second story addition**  
(courtesy of OSHA)

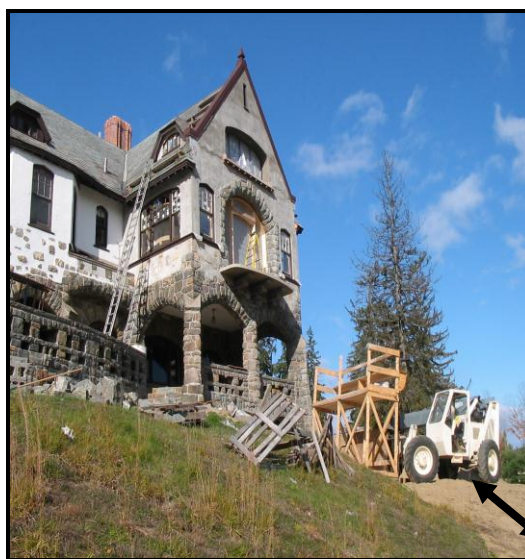
**Photo 2 Sloped terrain**  
(courtesy of OSHA)

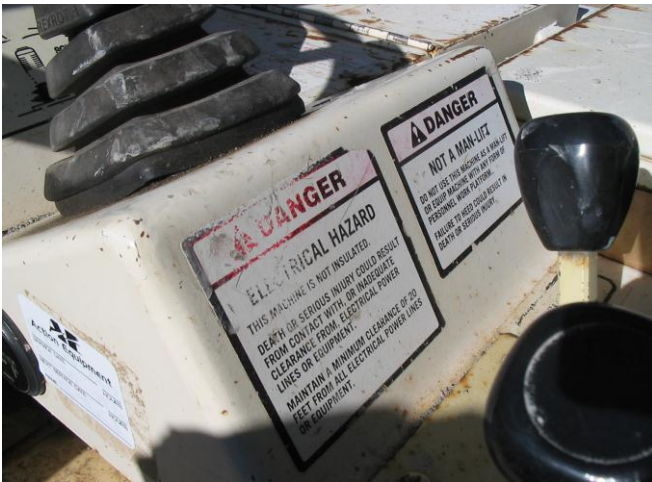
The telescopic handler involved in the incident was owned by the GC. This powered industrial truck (PIT), also referred to as a telehandler, rough terrain forklift or all-terrain forklift, had a maximum lift capacity of 6000 pounds and a telescopic boom with a maximum working height of 36 feet to reach higher elevations or access otherwise hard-to-reach spaces. At the time of the incident the boom was extended vertically about 25 feet and also extended horizontally approximately 16 feet, with a 9 foot high, double tiered platform attached. The manufacturer's warning plate inside the telescopic handler stated that the machine must not be used as a man-lift or equipped with any form of personnel work platform as it could result in death or serious injury (Photo 3). The manufacturer warned in the General Safety section of the operating manual that unauthorized modifications to the machine may impair the safety and machine function. The telescopic handler was observed by the OSHA investigator to be well-maintained in appearance, the operating manual was in the cab, and no operational problems were found when it was tested on the ground after the incident. The platform stability and the guardrail strength were not tested after the incident.

**Photo 3 Warning Plate Inside Cab***(courtesy of OSHA)*

**Recommendation #1:** *Employers and contractors should strictly follow the manufacturers' instructions on proper usage of the powered industrial trucks (PITs) such as telescopic handlers, and never use any PITs as man-lifts or equip them with any form of personnel work platform, if they are not so designed.*

**Discussion:** Employers and contractors should never use a powered industrial truck (PIT), such as a telescopic handler, as a man-lift or equip the machine with any form of personnel work platform, unless the specific PIT is designed by the manufacturer for that purpose. If PITs are designed only for material handling, the manufacturer provides warning plates on the equipment, in the cabs, as well as specific directions in the operating manual not to use as a man-lift or equip the PITs with any form of personnel work platform. Most plates or directions state that failure to heed the warnings could result in death or serious injury. If the manufacturer's operating manual states that a PIT is not to be used for elevating personnel platforms, use of the equipment to support such a platform and elevate personnel should be prohibited. Manufacturers cannot establish the range and capacity limitations for handmade or improper makeshift work platforms and they cannot assure the ability of a non-approved platform to perform its intended function safely. Strict adherence to the safety instructions from the manufacturer is necessary.

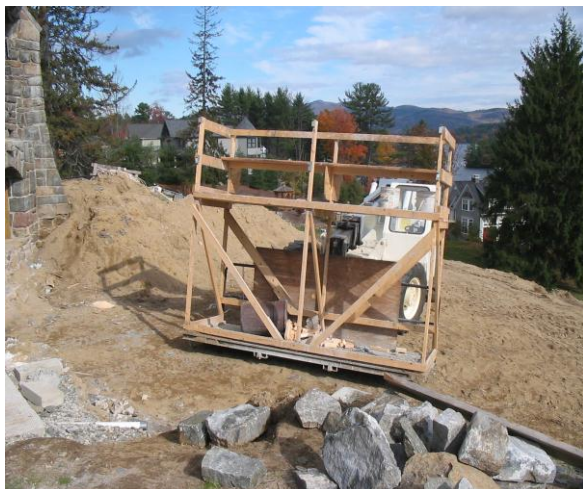
The double tiered platform was built two weeks prior to the incident by the victim and the GC employee who was present at the time of the incident. The platform was constructed of 2' x 4' lumber and plywood secured with metal deck screws; the final dimensions were 12' long, 4' wide and 9' high (Photos 4 and 5). It was fastened to the forks of the telescopic handler by “D” shackles and wooden wedges (Photo 6). A guardrail system was built on 4 sides of the platform with a top rail at a standard 42” height. The front side of the platform was equipped with metal brackets which allowed the guardrails built for the front of the platform to be removed. The upper tier of the platform was approximately 5 feet above the floor of the bottom tier. The total weight of the platform materials (lumber, plywood, bracing, clamps), equipment and supplies (tools, paintbrushes, paint, 5 gallon pails of stucco and water, mixing tray, 55 gallon plastic bucket of wood scraps) and occupant was estimated at 900 pounds at the time of the incident.

**Photo 4 Two-tier Platform**  
*(courtesy of OSHA)*

Numerous deficiencies were noted in the design, construction and operation of the platform.

- The two tier design resulted in a platform occupant floor height of 5 feet above the forks. The floor of the platform may not be located more than 8 inches above the normal load supporting surface of the forks per ANSI standards (B56.6).

- The floor of the platform was not a slip resistant surface, as required by ANSI standards.
- The length of the platform floor at 12' exceeded the maximum total allowable platform dimension of 9' 8". ANSI B56.6 8.25.1(b) requires a maximum length to be determined by measuring the width of the PIT across the load bearing tires plus 10" on either side. The width of the PIT in this incident measured 8 feet.

Unapproved platforms are not designed, constructed, erected or maintained in accordance with an approved standard and have not been proven safe for the purpose of lifting workers. In this incident, there was no evidence of tipping of the telescopic handler, but movement of the platform could have resulted in the occupant victim falling from or being catapulted off the platform as he worked on one side of the platform or as he attempted to exit onto the roof.

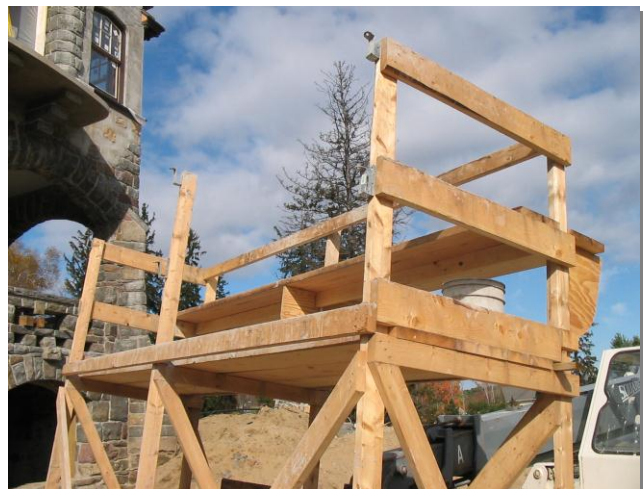
**Photo 5 Upper Tier**  
*(courtesy of OSHA)*

- No lanyard anchorage points for fall protection systems were installed on the platform.
- The design of the platform required that the platform be positioned from the cab of the telescopic handler and did not allow for any control by the occupant of the platform. This is not considered to be a deficiency, provided that when there is an occupant working at elevation in the platform, the operator is on the PIT or within 25 feet with the PIT visible. At the time of the incident, the GC employee was in the cab. During other work periods however, there was no operator in the cab or within 25 feet with the PIT visible.

- The wheels of the PIT were not chocked as the victim worked on the elevated platform.
- A ledge was built on the upper tier and had the potential to be used to achieve additional height in the platform. ANSI standards (B56.6) prohibit the use of railings, planks, ladders, etc. on the platform for the purpose of achieving additional reach or height.

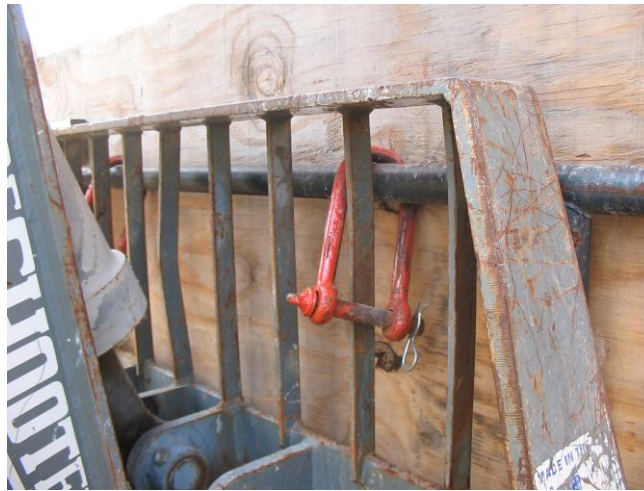
**Photo 6** Platform fastened to forks (courtesy of OSHA)

- The materials and tools on the platform were not secured to prevent any displacement or movement.
- 100% tie-off during platform to structure transfers and entry/exit three point contact safety procedures were not used. The platform was not lowered to the ground to allow for personnel to enter/exit. The victim had been observed climbing on parts of the telescopic handler, attempting to enter and exit the platform without any fall protection.

**Recommendation #2:** *Employers and contractors should never modify or authorize to modify powered industrial trucks (PITs), such as telescopic handlers, in any way.*

**Discussion:** Employers and contractors should not modify a powered industrial truck (PIT), such as a telescopic handler, without the written approval of the manufacturer, as modifications and changes

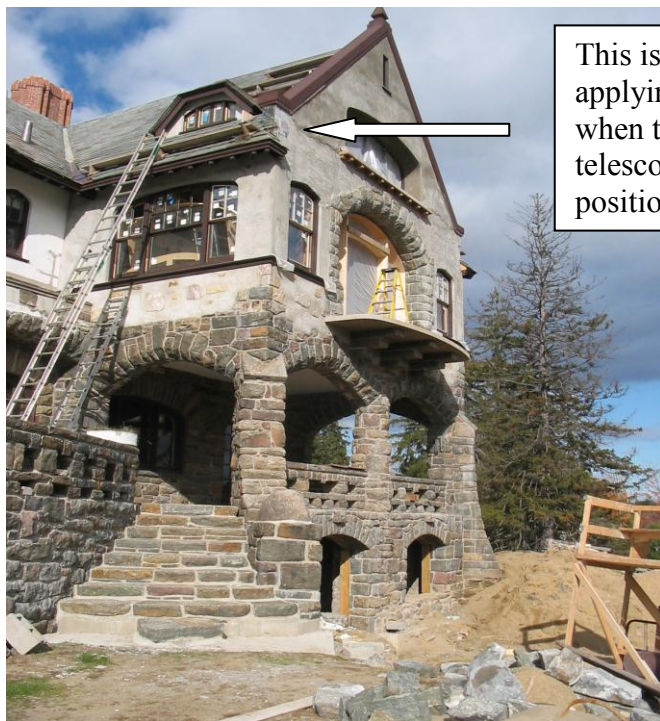
The victim had been observed by the GC employee on site positioning the platform with the telescopic handler and then accessing the platform from a step ladder on the balcony or by climbing down into the platform from the roof jacks (Photo 7). The front guardrails were not installed on the platform. The victim was working with the unprotected front side of the platform facing the building; he was not wearing any type of personal fall protection.

This is the area where the victim was applying stucco and painting trim when the incident occurred. The telescopic handler platform was positioned to the left of this area.

**Photo 7** Note the stepladder on the balcony and extension ladder access to the roof. (courtesy of OSHA)

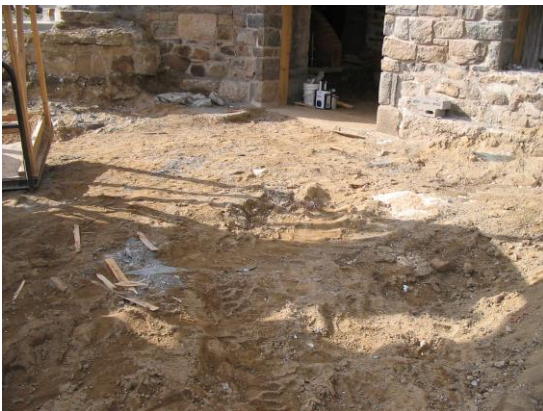
- The telescopic handler was positioned on a small, sandy area at the rear of the building. Although the area was relatively flat, the surface was rutted and irregular, another condition that is known to contribute to increased instability of an elevated platform (Photo 9).

**Photo 8** Rutted, uneven surface where the telescopic handler was positioned (photo courtesy of OSHA)

In this incident, work site heights up to 40 feet above the ground needed to be accessed, the terrain was sloped with rutted surfaces and limited flat locations for equipment placement, the construction activities of roofing, painting and stucco work required the lifting of materials and workers, and hard to reach areas were identified that required extensions of the platform at or beyond the reach capabilities of the equipment that was selected. Consultations with safety and equipment specialists to review the specific applications required could have led to the selection of the correct equipment to address the specific hazards and site conditions needed to maintain a safe work environment.
