FATALITY ASSESSMENT AND CONTROL EVALUATION

**Operator Killed when
Horizontal Auger Boring Machine Overturned
Case Report 11NY043****CASE SUMMARY**

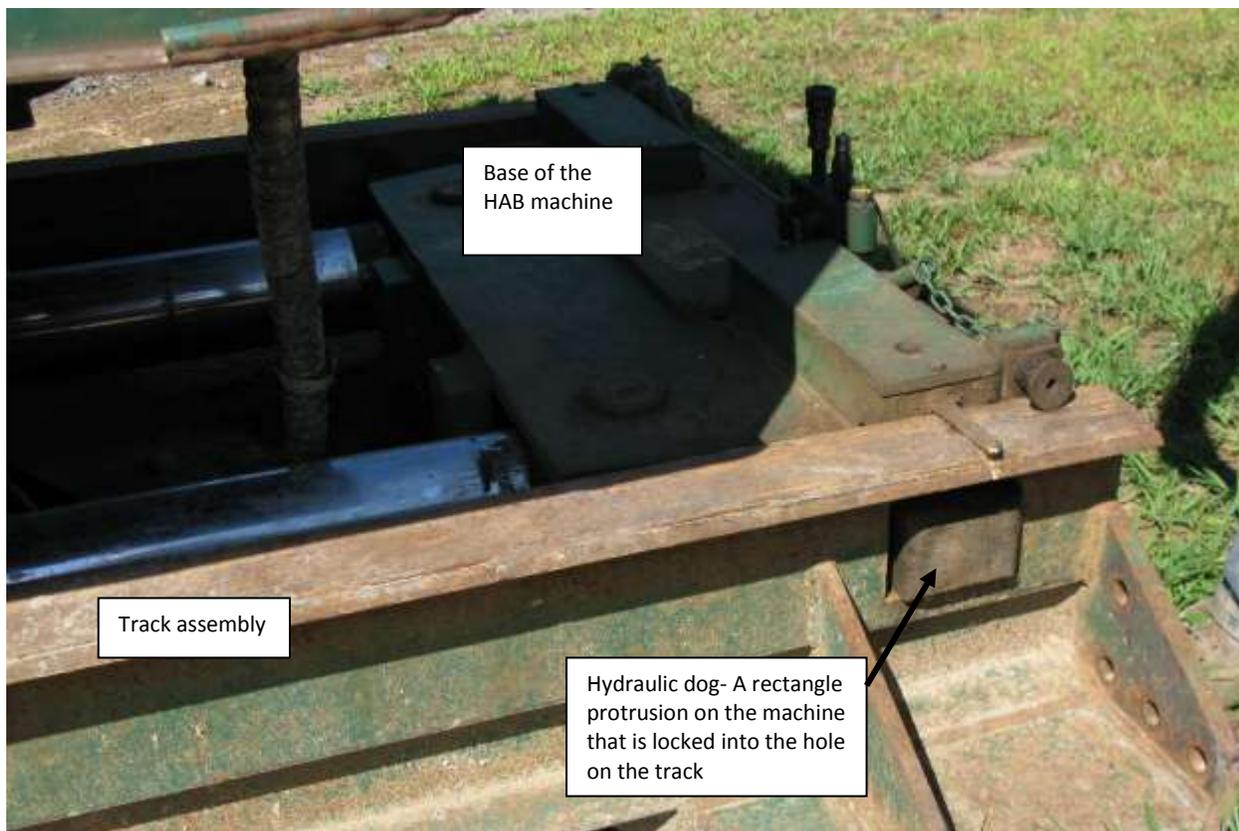
The machine was mounted on a track assembly comprised of two pairs of tracks connected by steel beams. The track assembly was approximately 32 ft. (9.8 m) long and 5 ft. wide. There were rectangular openings (holes) on the tracks. The base of the HAB machine had movable rectangular protrusions (hydraulic dogs) controlled by hydraulic power that can be locked into the holes on the tracks to prevent machine movement on the tracks (Photo 2). The dimensions of the machine were 60 in (1.5 m) wide, 144 in (3.7 m) long and 52.5 in (1.3 m) high. The centerline of the auger was 1.88 ft. above the ground. The combined weight of the machine and the track assembly (auger string excluded) was approximately 15,800 lbs. (7,167 kg).

Photo 2. The HAB machine is locked to the track assembly by the rectangle protrusions engaged into the holes on the track assembly.

To set up the machine, workers placed one-inch thick steel plates 64 in x 108 in (1.6 m x 2.7 m) on compacted soil and placed the track assembly on top of the steel plates. The track assembly was aligned with the casing and the designed grade before the machine was mounted. The track assembly was not anchored to the ground.

- 7) ***Modify the machine base and track assembly design so that the machine can be anchored into the ground.***
- 8) ***Warn operators of the danger of boring inside a preinstalled casing without stabilizing the machine.*** It appeared that the method described in this case is frequently used by the industry. Manufacturers should specifically warn operators in the operators manual about the danger of machine upset when boring inside a preinstalled casing without taking measures to stabilize the machine.

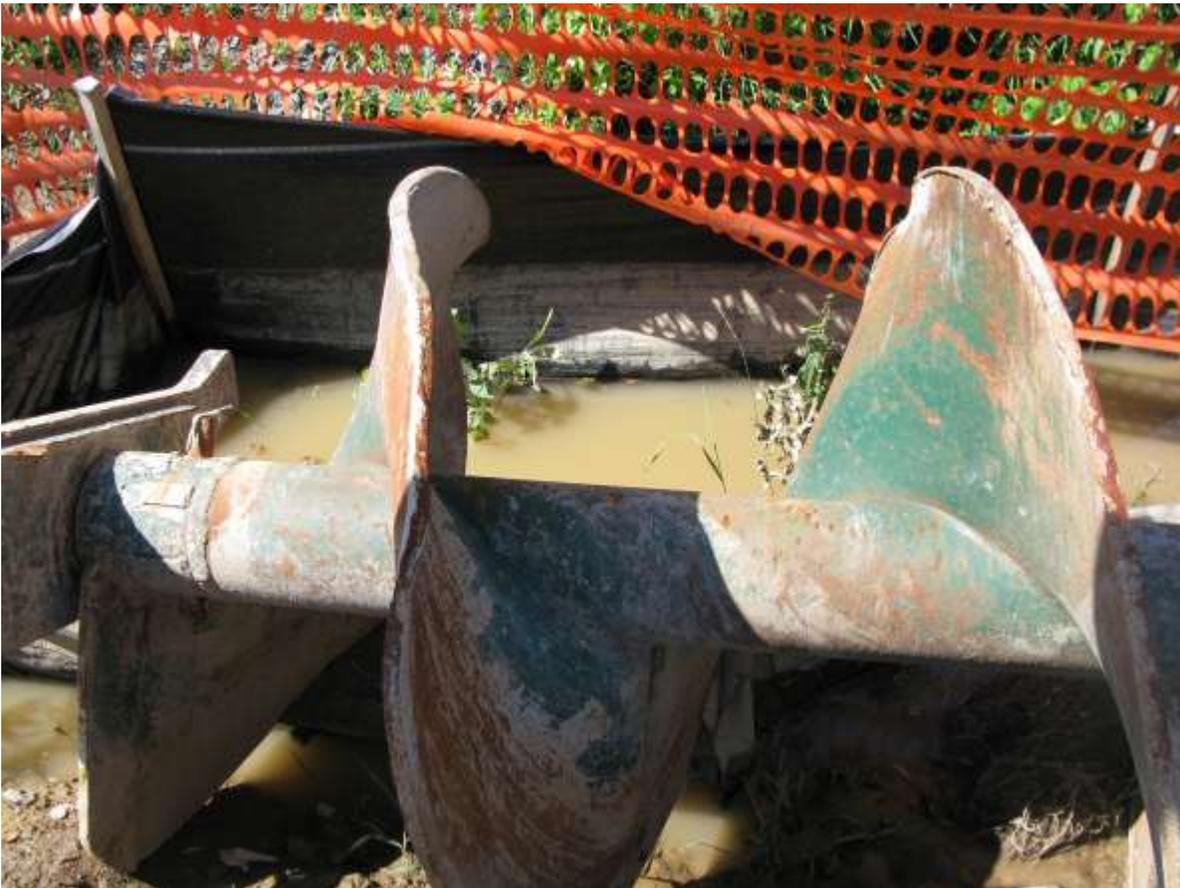
The post incident examination found that the HAB machine was operational resulting in no functional damage from the incident and the auger string was not out of alignment. The blades of the auger were bent during the incident (Photo 3) according to the owner of the company. It appeared that the auger was jammed by the spoils inside the casing. According to the OSHA investigation, there were rocky materials in the area being bored and large boulders and cobbles inside the pipe casing when the auger string was removed. The throttle position indicated that the machine was operating at or near full power when the machine overturned.

Photo 3. The bent auger blades indicate that the auger was caught by the spoils inside the casing.
